Annual Inspection

Mid Suffolk District Council

Buxhall

Off Mill Road, Suffolk, IP14 3DS

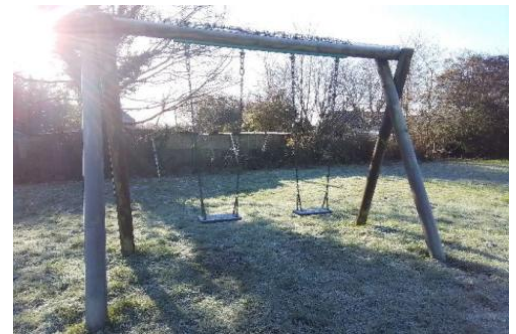
Item: 1 Bay 2 Seat (Flat)
Manufacturer: A.E.Evans
Surface Type: Grass Matrix Tiles
Item Quantity: 1
Equipment Compliance: Yes
Surface Area Compliance: Yes

The bushes are showing signs of wear - Monitor for any further deterioration and replace as required

There is some wear to the shackles - Monitor for any further deterioration and replace when 40% worn

There is some notable evidence of chain wear - Monitor for any further deterioration and replace when 40% worn

There is some strimmer / machinery damage apparent on the posts, this can penetrate the preservative applied to the timber and accelerate the rotting process - Monitor for any deterioration (rot) and replace as required

There is some evidence of rot in the timber - Monitor for any further deterioration and replace as required

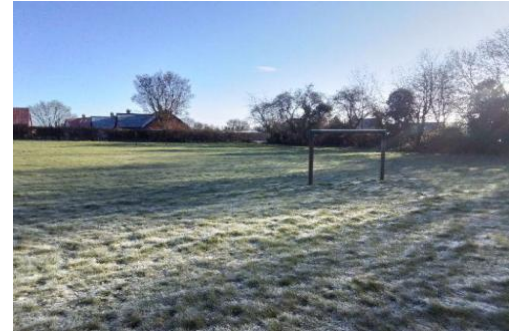
Item: Goal End
Manufacturer: Not Identified
Surface Type: Grass
Item Part Number:
Item Quantity: 2
Equipment Compliance: N/A
Surface Area Compliance: N/A
Total Findings: 3

There is some strimmer / machinery damage apparent on the posts, this can penetrate the preservative applied to the timber and accelerate the rotting process - Monitor for any deterioration (rot) and replace as required

There is some evidence of rot in the timber - Monitor for any further deterioration and replace as required

The timber has a number of splits/shakes or air cracks and this may affect the stability or allow water ingress which will accelerate the rotting process - Monitor to ensure the splits do not cross through fixing points of the structure and/or cause any instability

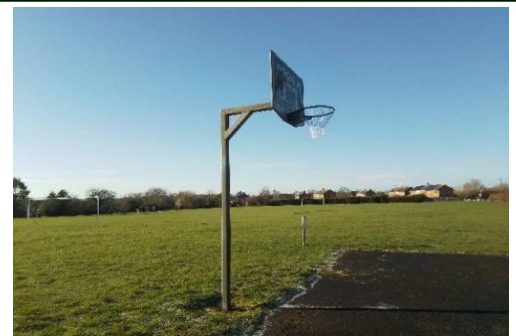
Item: Basketball Post
Manufacturer: Not Identified
Surface Type: Tarmac
Item Quantity: 1
Equipment Compliance: No
Surface Area Compliance: N/A

There is moderate damage to the surface - Repair the damaged areas of surfacing

There is algae, silt or moss growth on the surface resulting in slippery conditions - Clean and treat appropriately

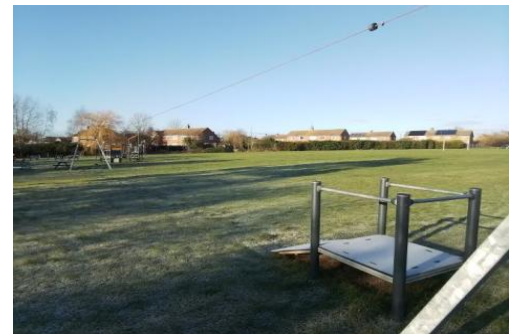
Item: Cable Runway
Manufacturer: Kompan Ltd
Surface Type: Grass Matrix Tiles
Item Quantity: 1
Equipment Compliance: Yes
Surface Area Compliance: Yes

We have completed a visual inspection of the suspension links, cable and fixing points from ground level, however it is not possible to fully inspect these areas without either hiring equipment to gain access or removing the cable and suspension and inspecting at ground level. We recommend that the main cable and fixing security is thoroughly inspected at least in accordance with the manufacturers recommendations to check for wear, damage, security or internal rusting; this will help to ensure the continued safe use of the equipment - Inspect in accordance with the manufacturers recommendations

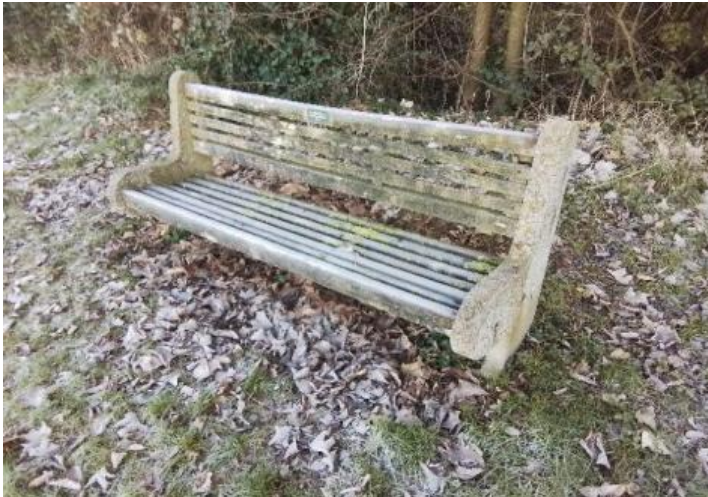
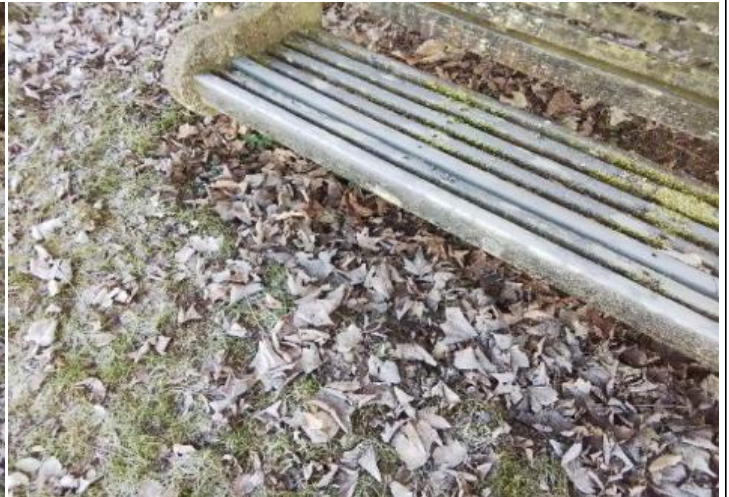
Item: Ancillary Items - Bench
Manufacturer: Not Identified

Finding: The area around the item has eroded and may become slippery

Action: Reinstate eroded area

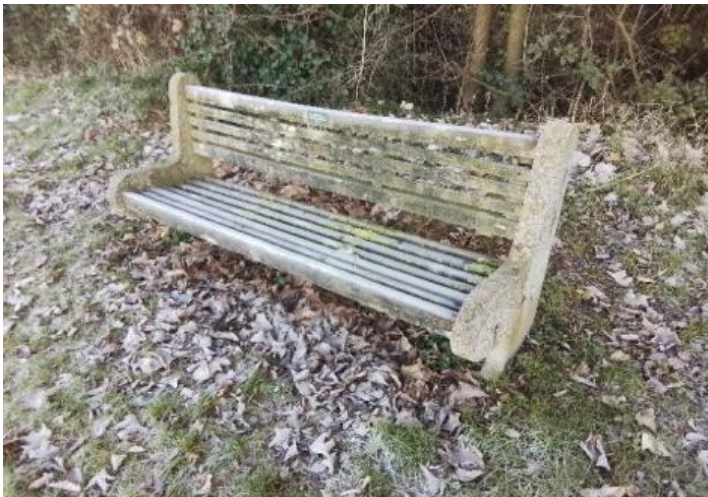
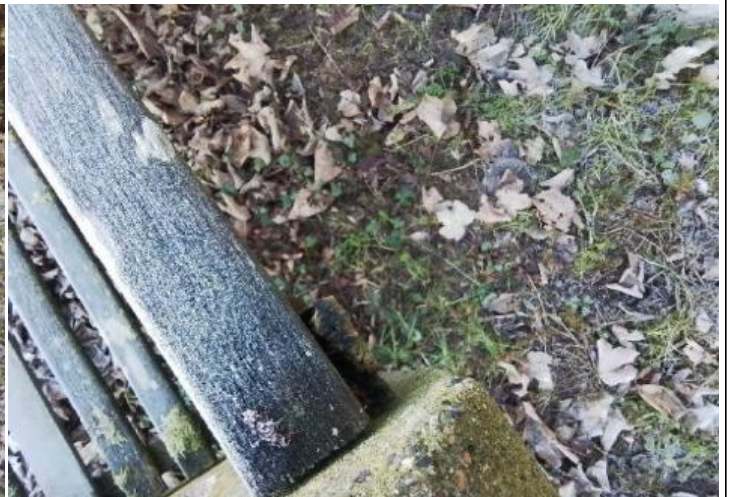
Item: Ancillary Items - Bench
Manufacturer: Not Identified

Finding: There is some evidence of rot in the timber

Action: Monitor for any further deterioration and replace as required

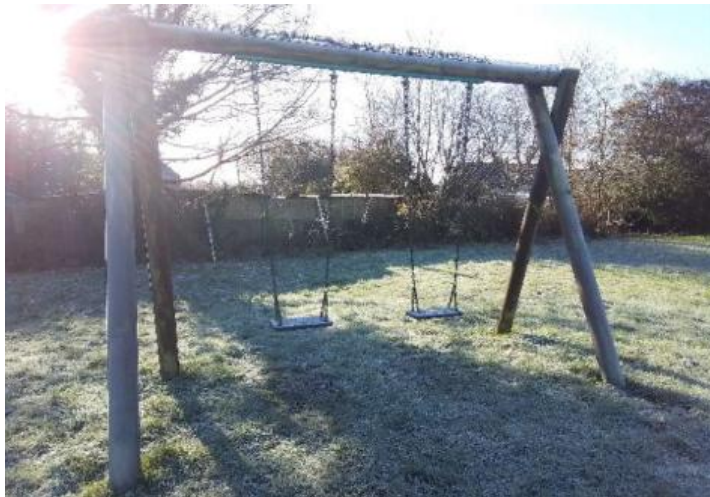
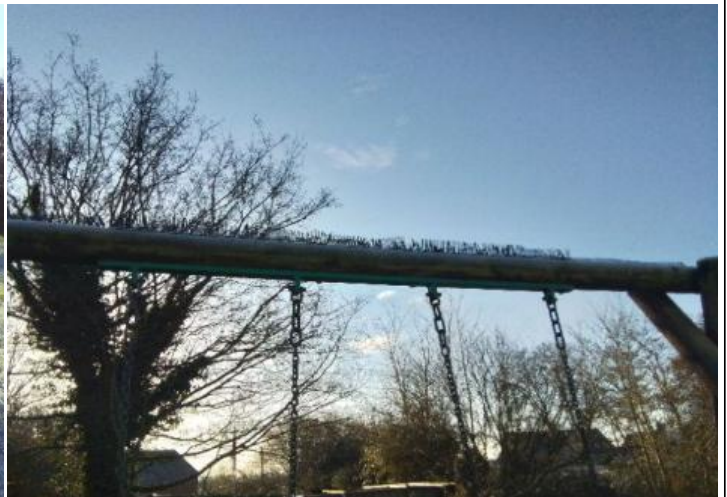
Item: Swings - 1 Bay 2 Seat (Flat)
Manufacturer: A.E.Evans

Finding: There are anti bird devices attached to the cross beam

Action: Remove from item

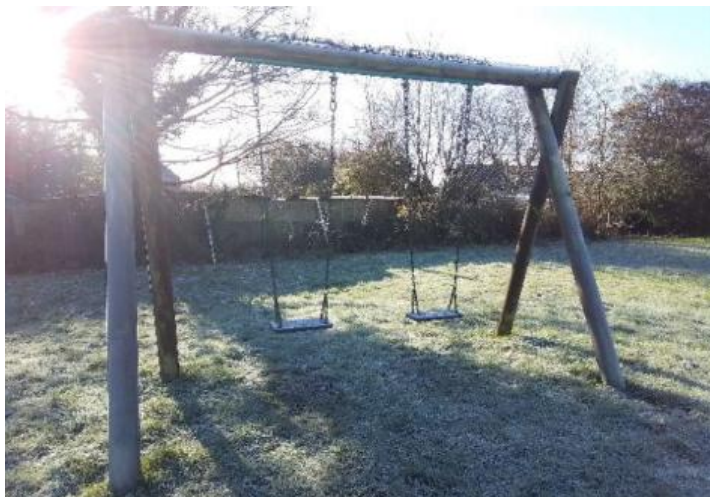
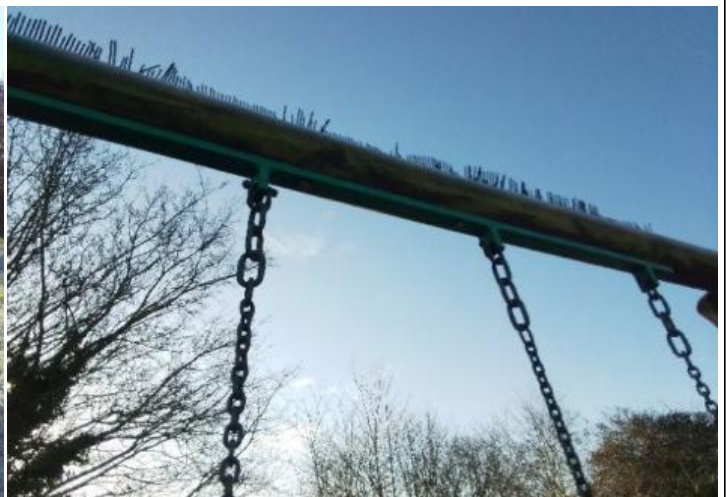
Item: Swings - 1 Bay 2 Seat (Flat)
Manufacturer: A.E.Evans

Finding: The bushes are showing signs of wear

Action: Monitor for any further deterioration and replace as required

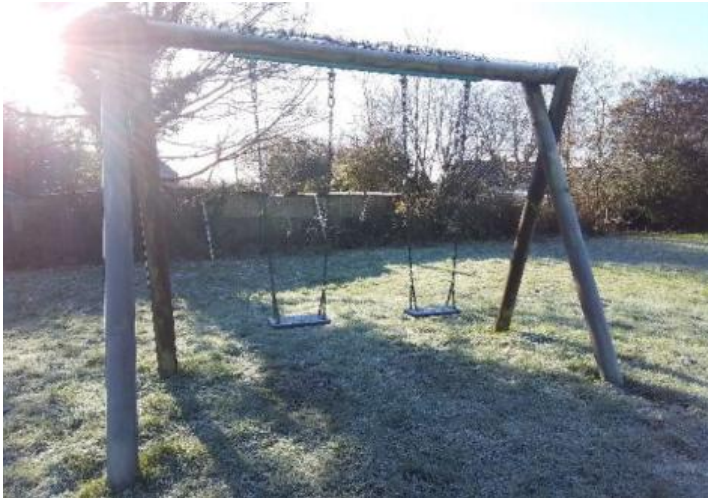
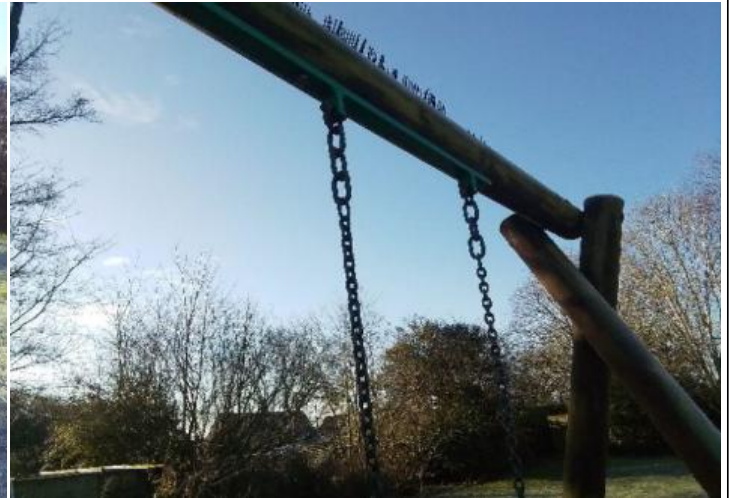
Item: Swings - 1 Bay 2 Seat (Flat)
Manufacturer: A.E.Evans

Finding: There is some wear to the shackles

Action: Monitor for any further deterioration and replace when 40% worn

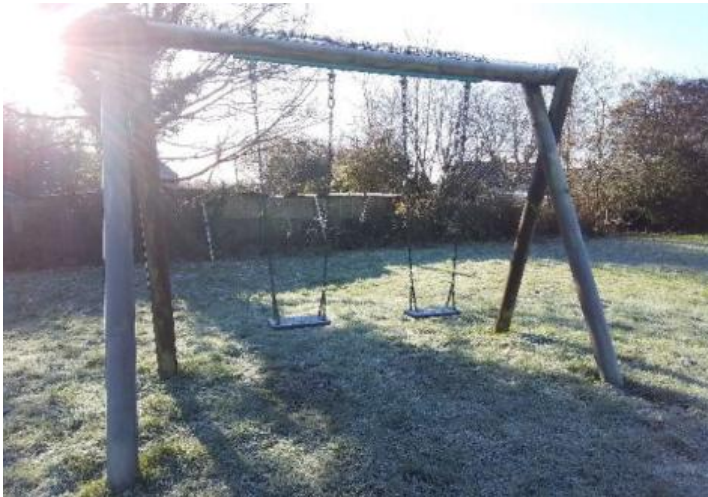
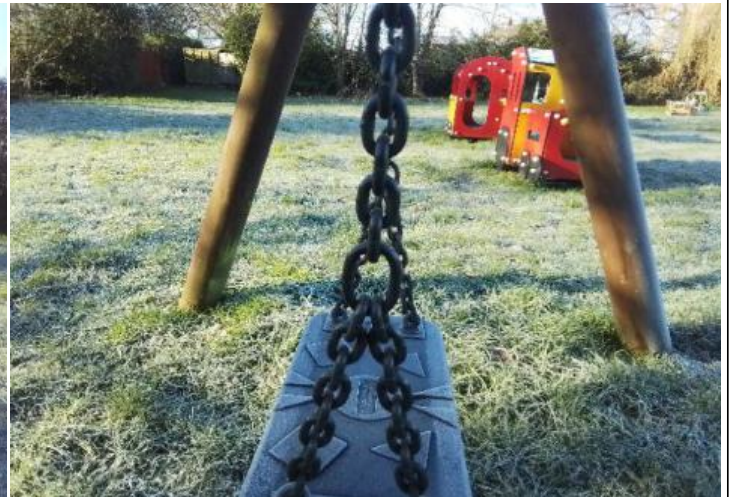
Item: Swings - 1 Bay 2 Seat (Flat)
Manufacturer: A.E.Evans

Finding: There is some notable evidence of chain wear

Action: Monitor for any further deterioration and replace when 40% worn

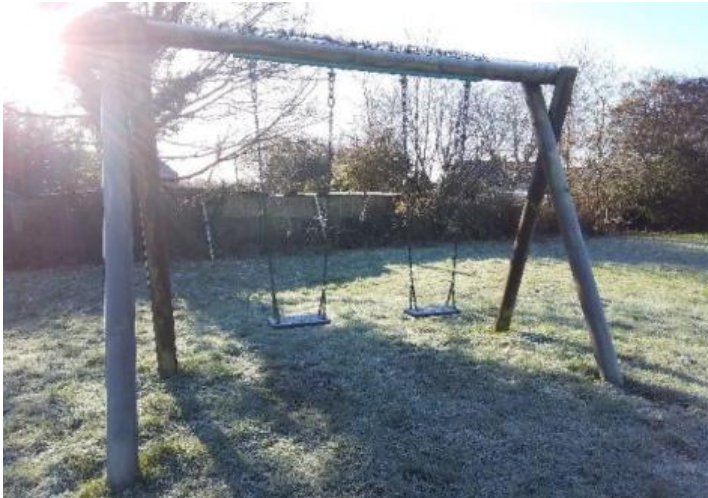
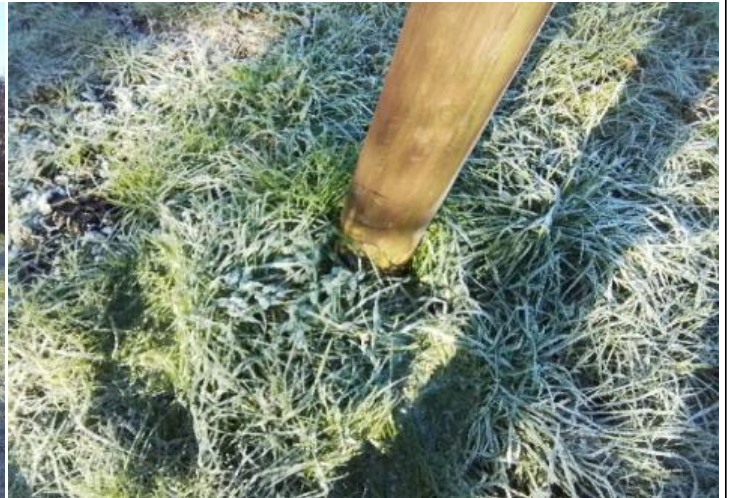
Item: Swings - 1 Bay 2 Seat (Flat)
Manufacturer: A.E.Evans

Finding: There is some strimmer / machinery damage apparent on the posts, this can penetrate the preservative applied to the timber and accelerate the rotting process

Action: Monitor for any deterioration (rot) and replace as required

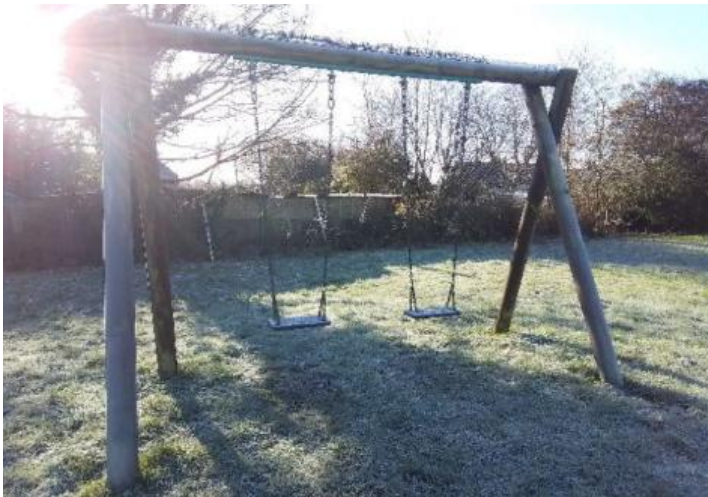
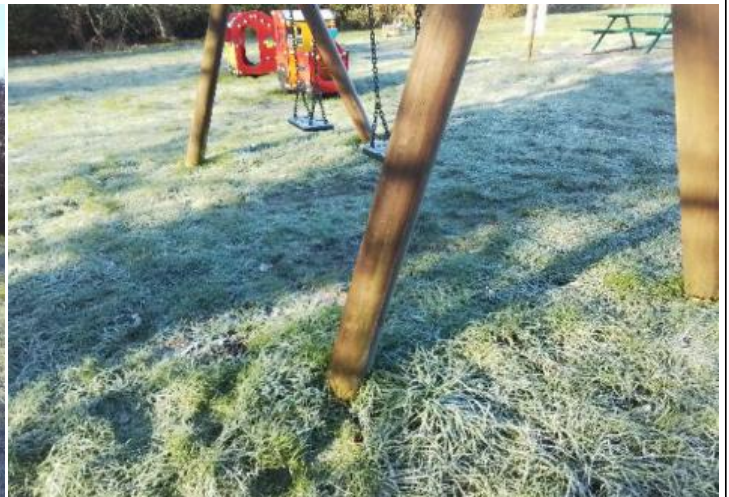
Item: Swings - 1 Bay 2 Seat (Flat)
Manufacturer: A.E.Evans

Finding: There is some evidence of rot in the timber

Action: Monitor for any further deterioration and replace as required

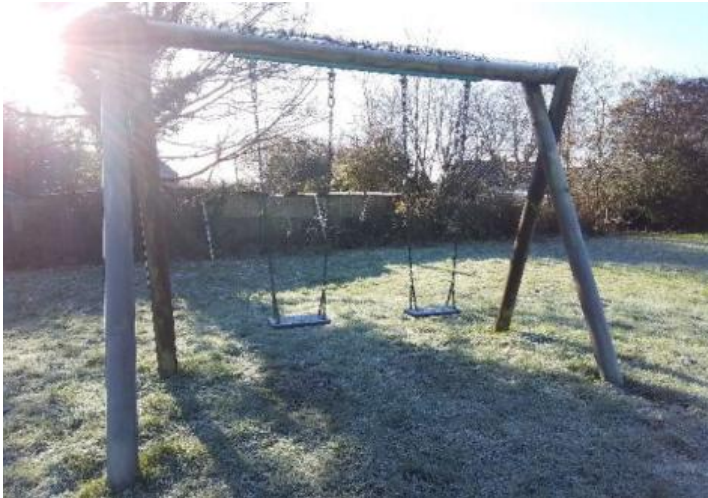
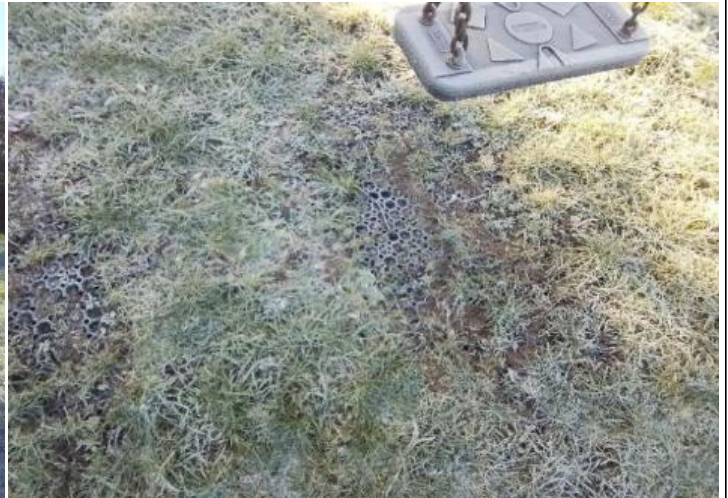
Item: Swings - 1 Bay 2 Seat (Flat)
Manufacturer: A.E.Evans

Finding: The grass mats are silted up, the soil is compacted and the area will become very slippery when the soil is wet. **Action:** Reinstate as required

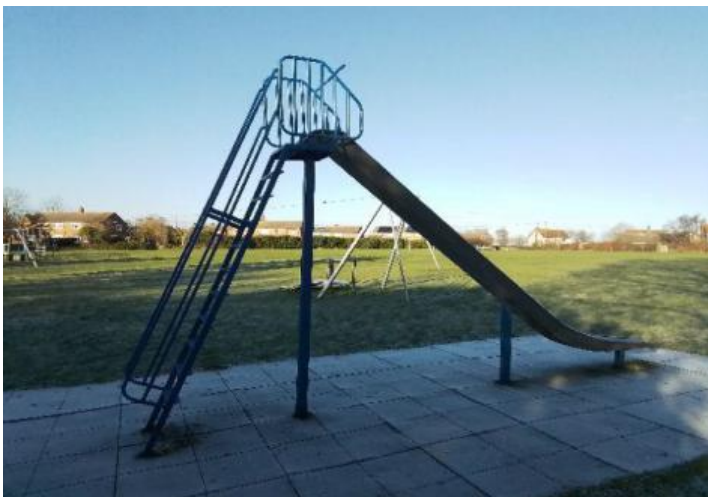
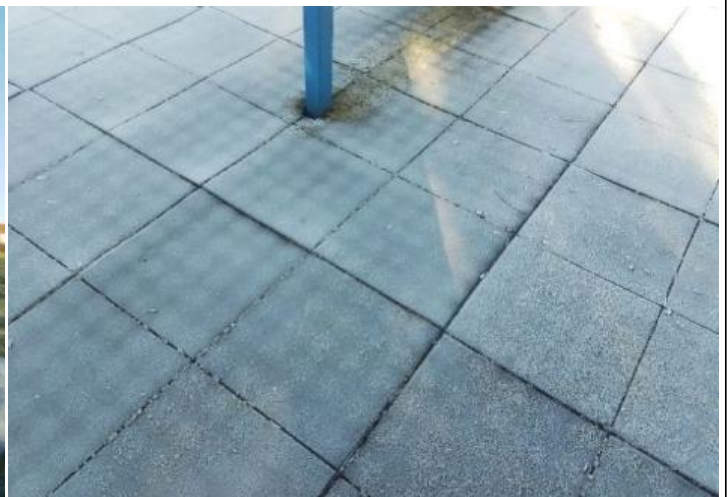
Item: Other - Free Standing Slide
Manufacturer: Wicksteed Playgrounds

Finding: There are gaps opening in between the tiles **Action:** Monitor for any further deterioration and repair as required

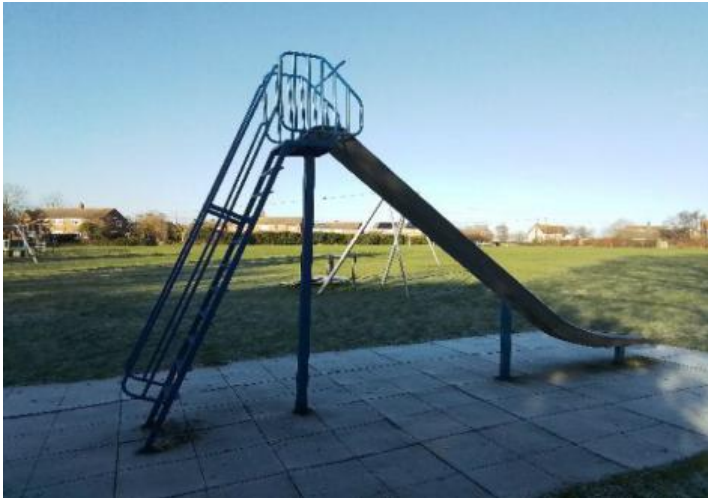
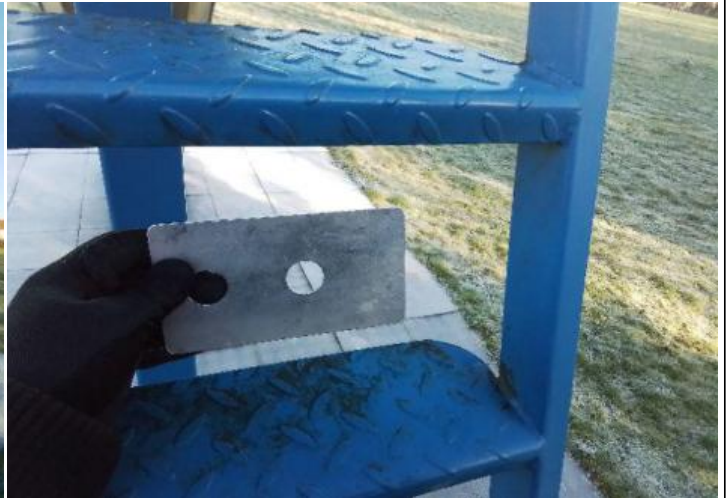
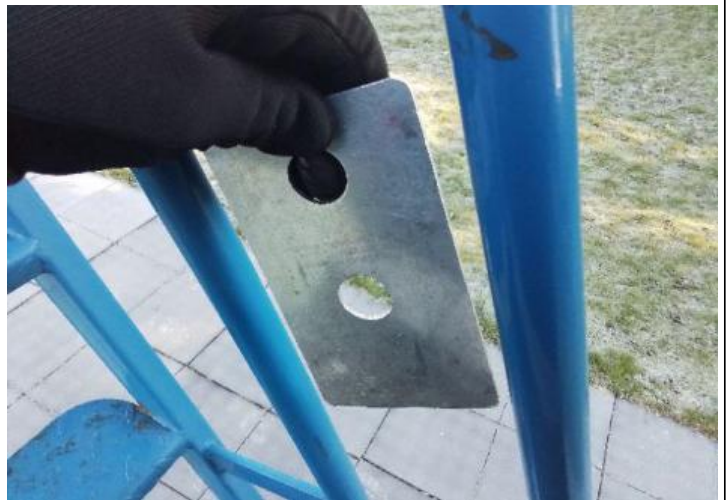
Item: Other - Free Standing Slide
Manufacturer: Wicksteed Playgrounds

Finding: The item fails to meet the requirements of BS EN 1176 Part 1 4.2.7.2 head and neck entrapment in the barriers and/or steps

Action: Monitor - No remedial work recommended

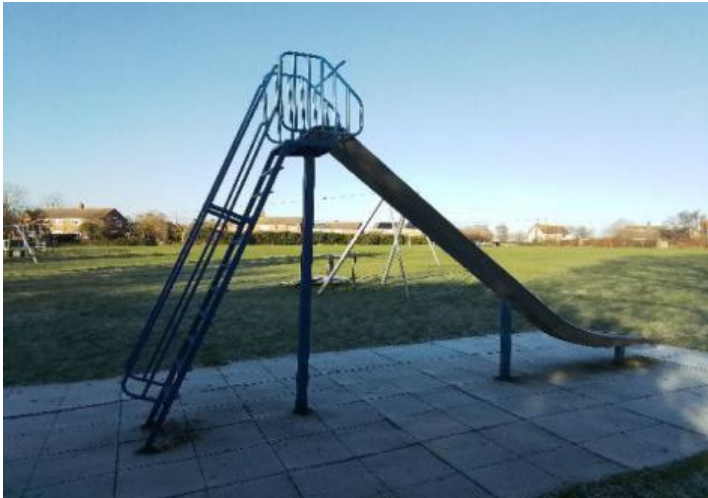
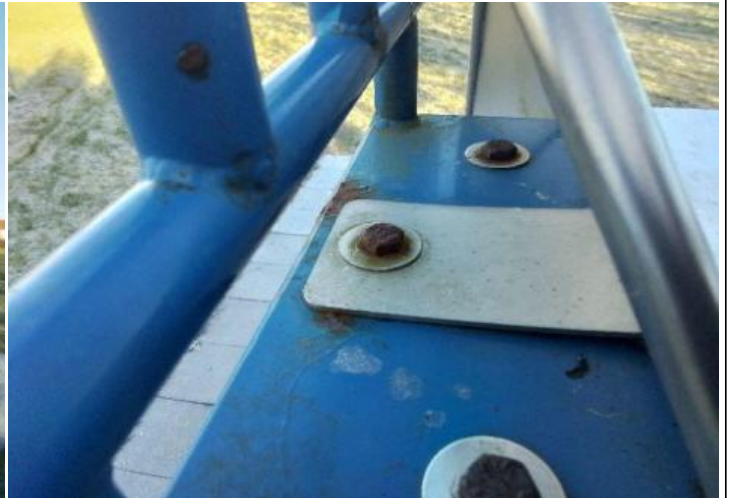
Item: Other - Free Standing Slide
Manufacturer: Wicksteed Playgrounds

Finding: The paintwork on this item has been damaged or worn exposing the metal underneath which is rusting

Action: Treat any rusting components and repaint

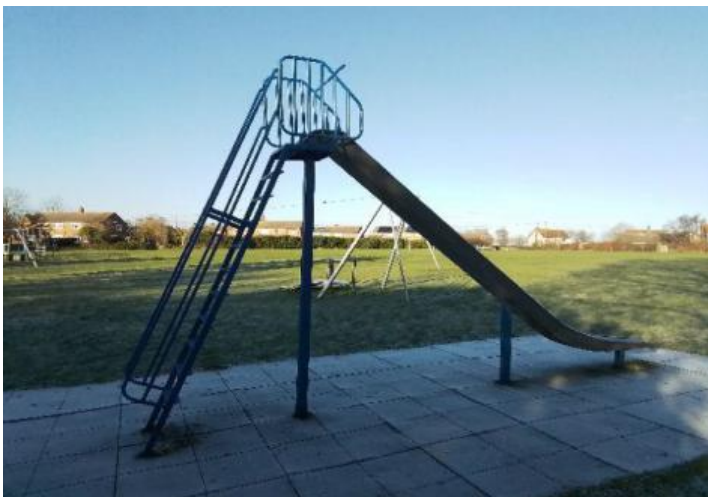
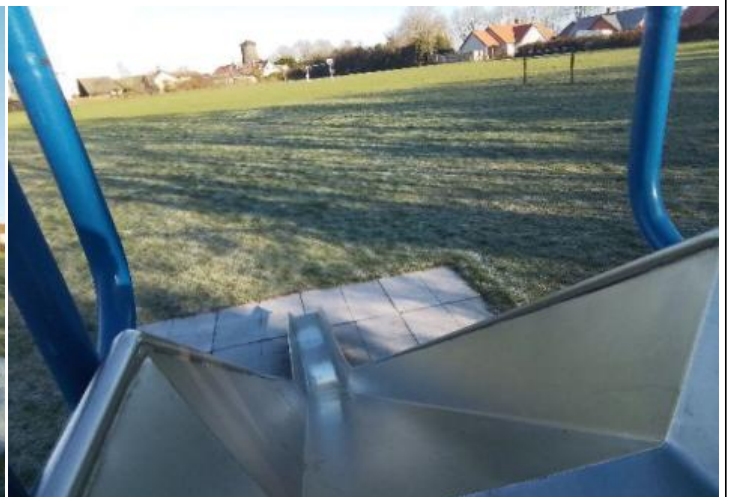
Item: Other - Free Standing Slide
Manufacturer: Wicksteed Playgrounds

Finding: There are a number of dents in the slide surface

Action: Monitor for any further deterioration and repair as required

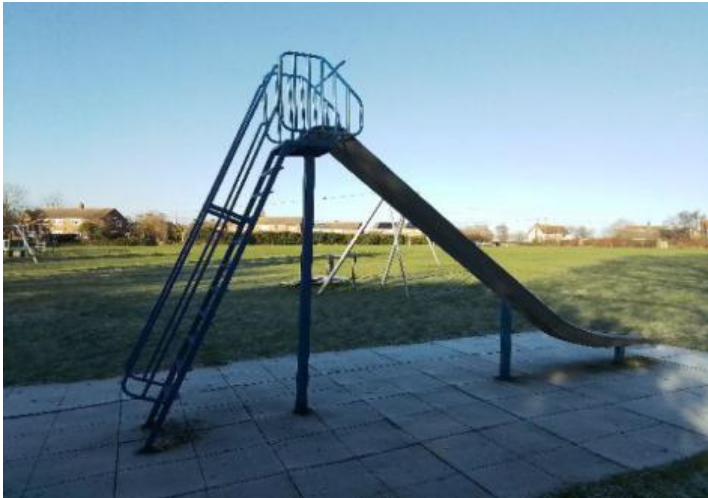
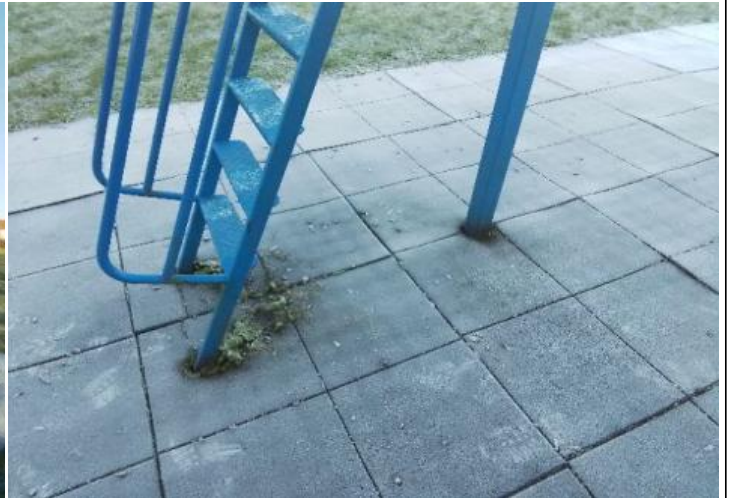
Item: Other - Free Standing Slide
Manufacturer: Wicksteed Playgrounds

Finding: There is algae, silt or moss growth on the surface resulting in slippery conditions

Action: Clean and treat appropriately

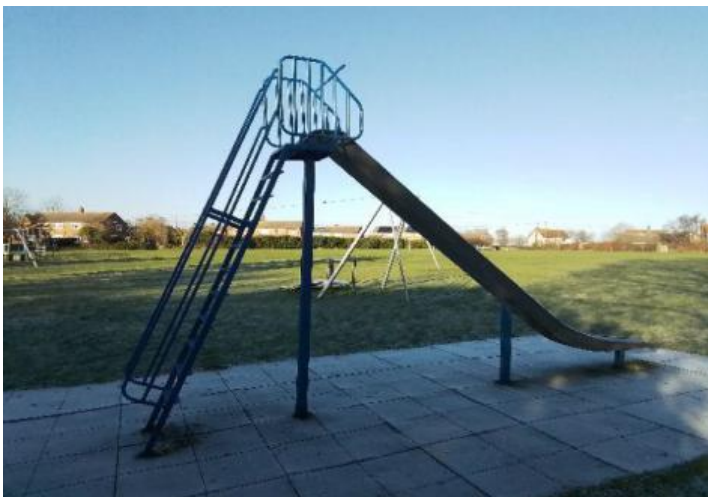
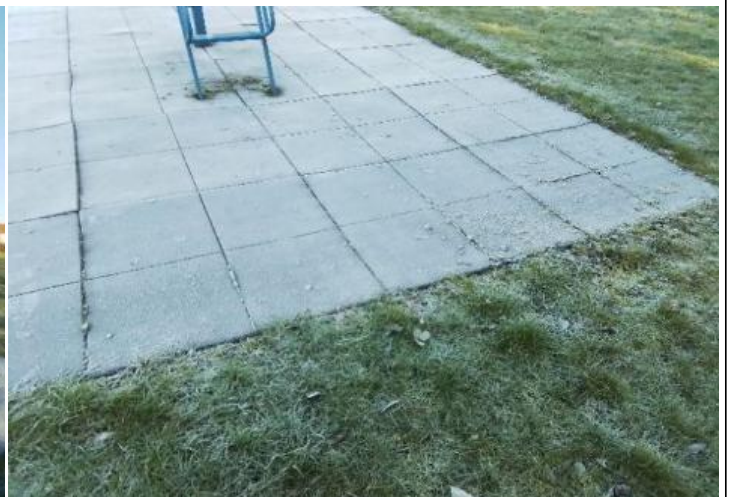
Item: Other - Free Standing Slide
Manufacturer: Wicksteed Playgrounds

Finding: There are trip hazards at the edges of the surface

Action: Reinstate surrounding surface levels to remove the trip points

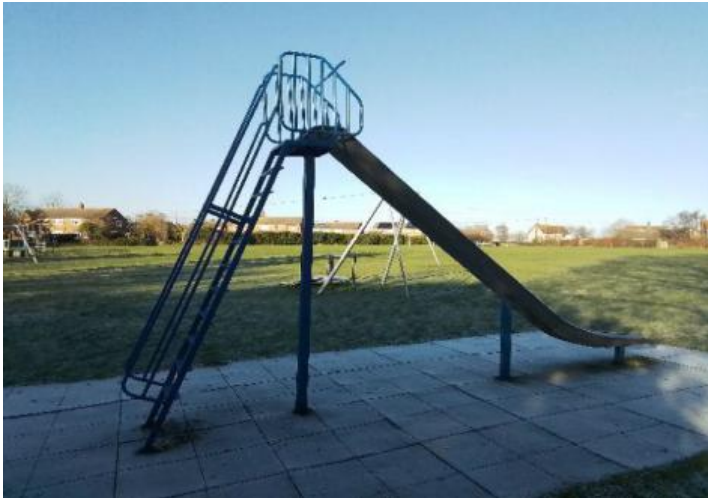
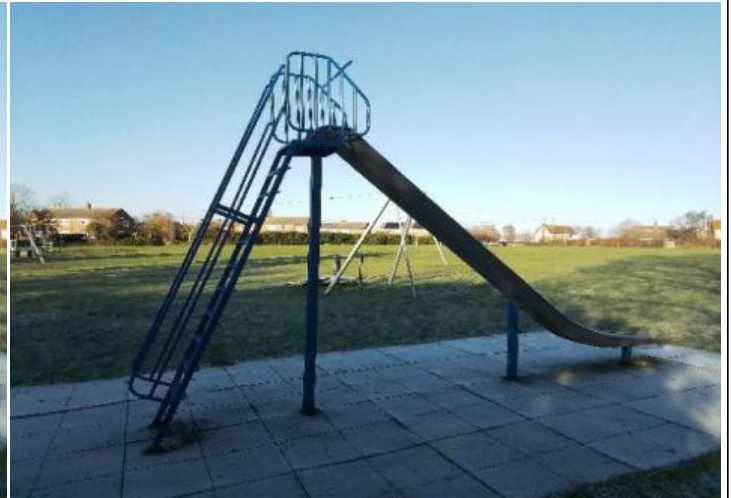
Item: Other - Free Standing Slide
Manufacturer: Wicksteed Playgrounds

Finding: The surfacing dimensions are short and do not meet with the requirements of the current applicable standard

Action: Monitor - no remedial action recommended

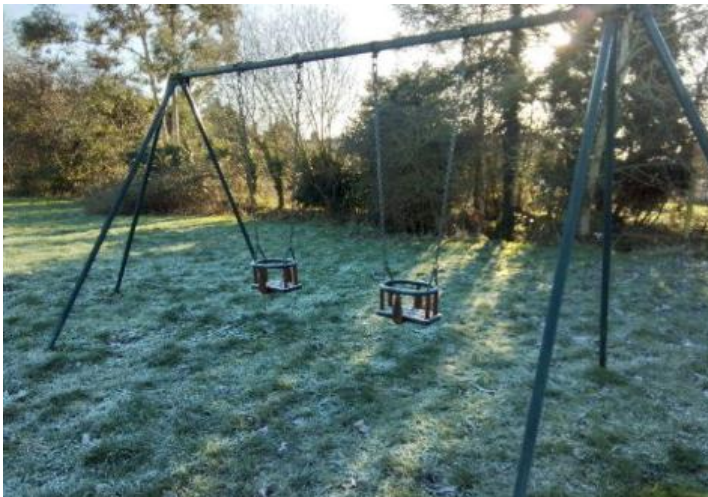
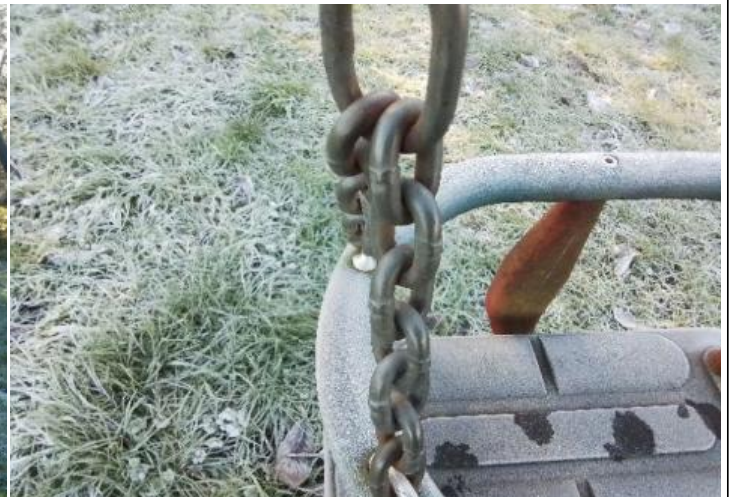
Item: Swings - 1 Bay 2 Seat (Cradle)
Manufacturer: Not Identified

Finding: There is some notable evidence of chain wear

Action: Monitor for any further deterioration and replace when 40% worn

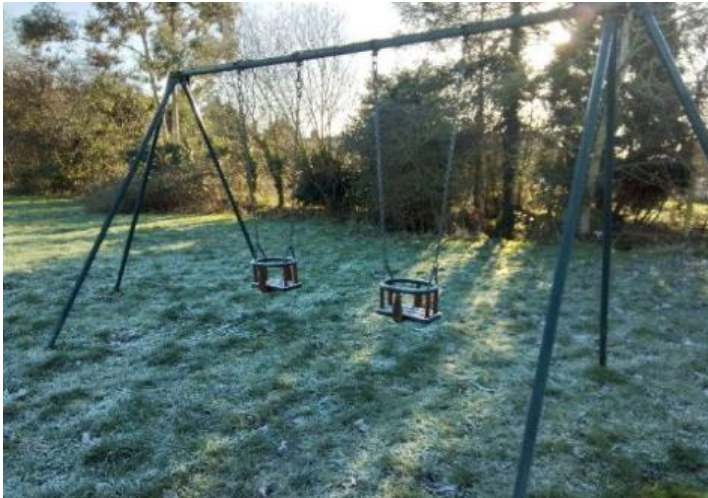
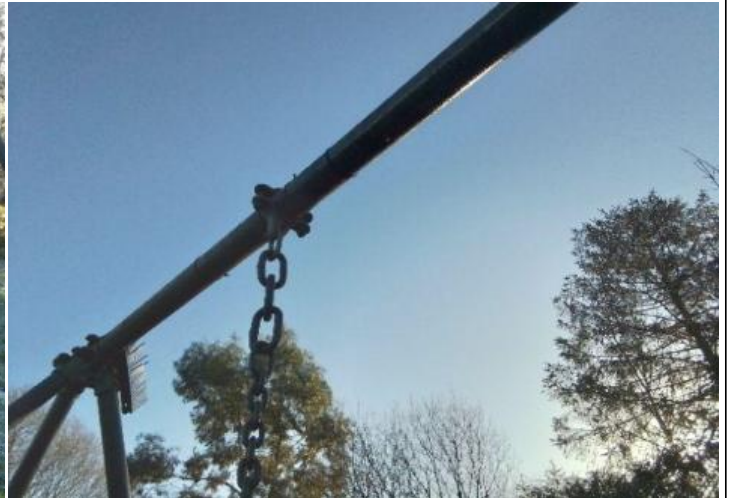
Item: Swings - 1 Bay 2 Seat (Cradle)
Manufacturer: Not Identified

Finding: The bushes are showing signs of wear

Action: Monitor for any further deterioration and replace as required

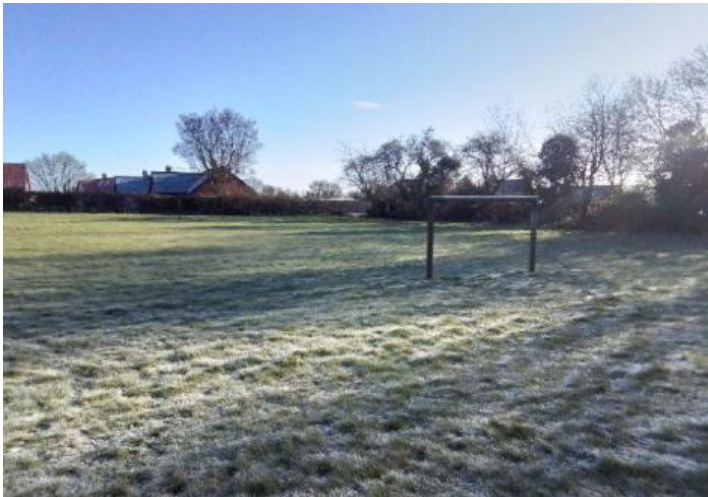
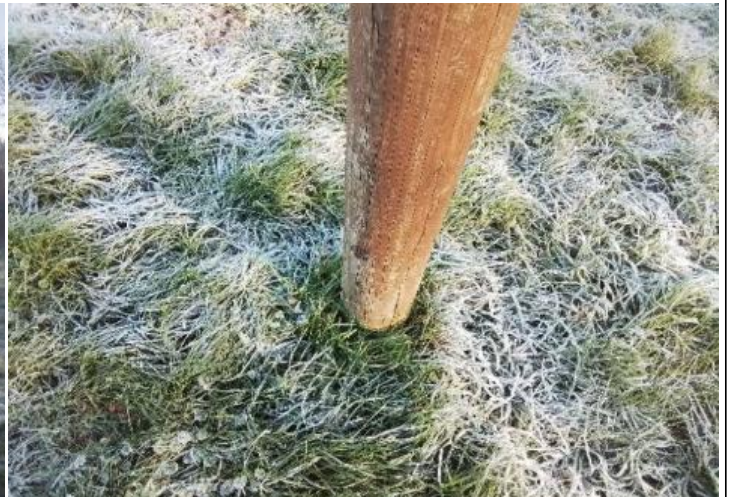
Item: Multi Use Games Area - Goal End
Manufacturer: Not Identified

Finding: There is some strimmer / machinery damage apparent on the posts, this can penetrate the preservative applied to the timber and accelerate the rotting process

Action: Monitor for any deterioration (rot) and replace as required

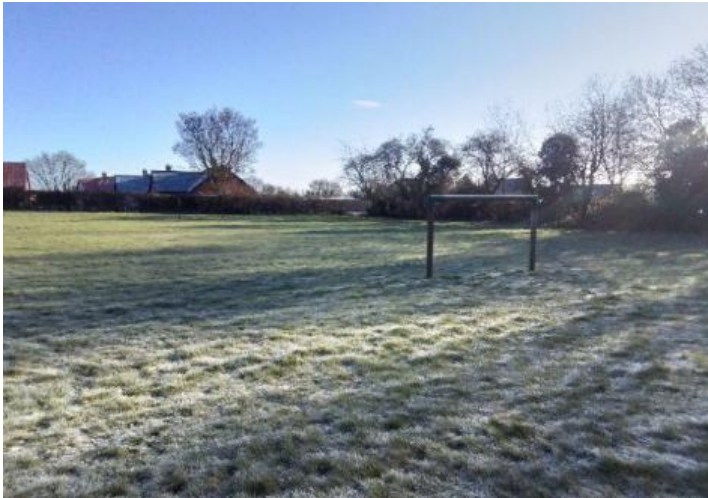
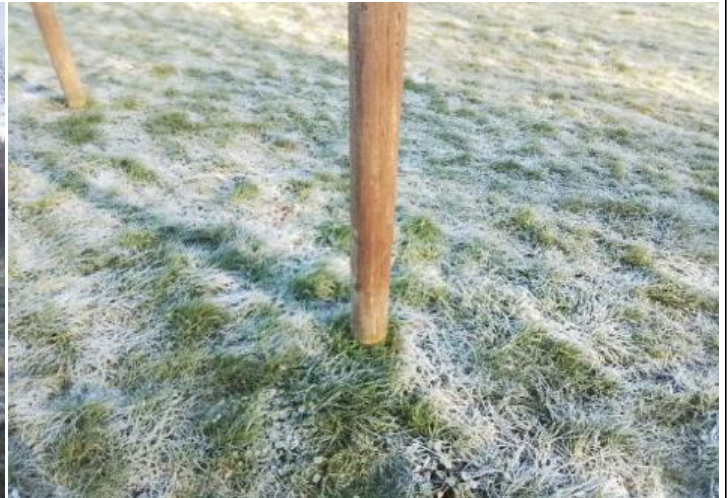
Item: Multi Use Games Area - Goal End
Manufacturer: Not Identified

Finding: There is some evidence of rot in the timber

Action: Monitor for any further deterioration and replace as required

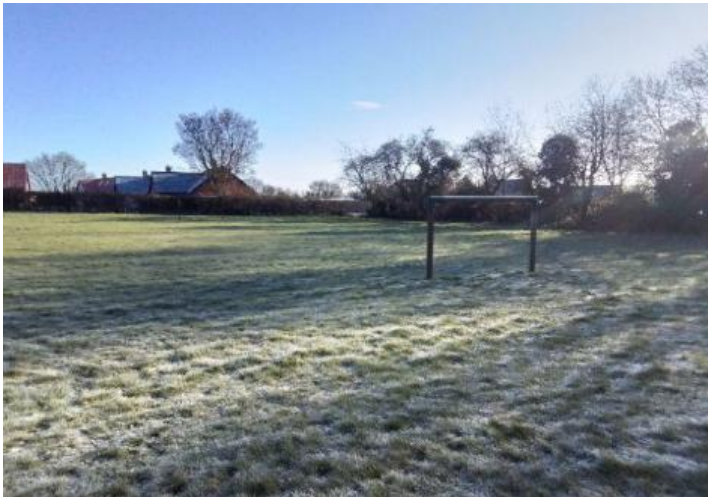
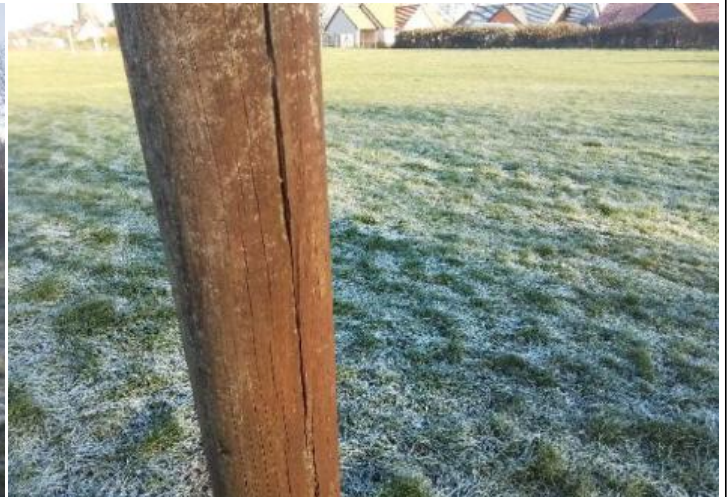
Item: Multi Use Games Area - Goal End
Manufacturer: Not Identified

Finding: The timber has a number of splits/shakes or air cracks and this may affect the stability or allow water ingress which will accelerate the rotting process

Action: Monitor to ensure the splits do not cross through fixing points of the structure and/or cause any instability

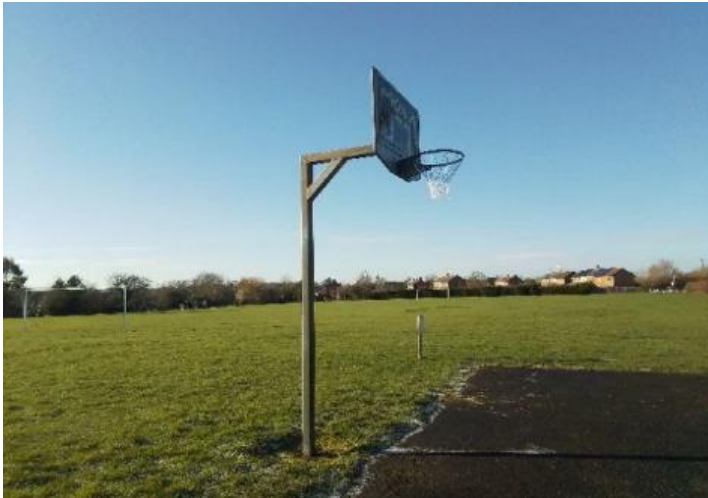
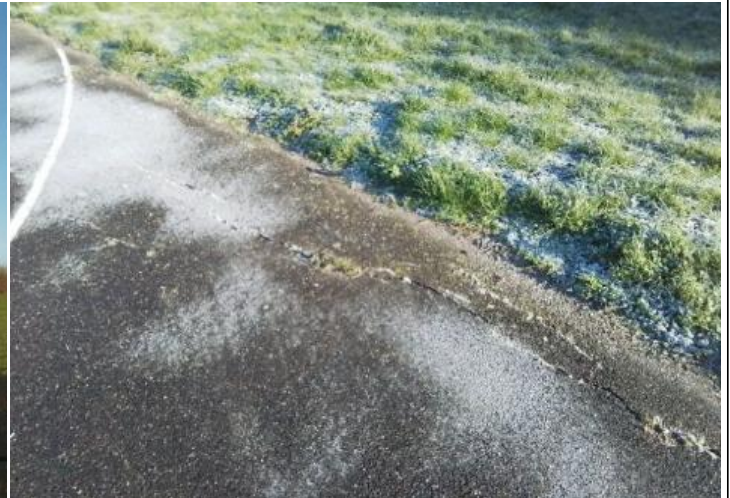
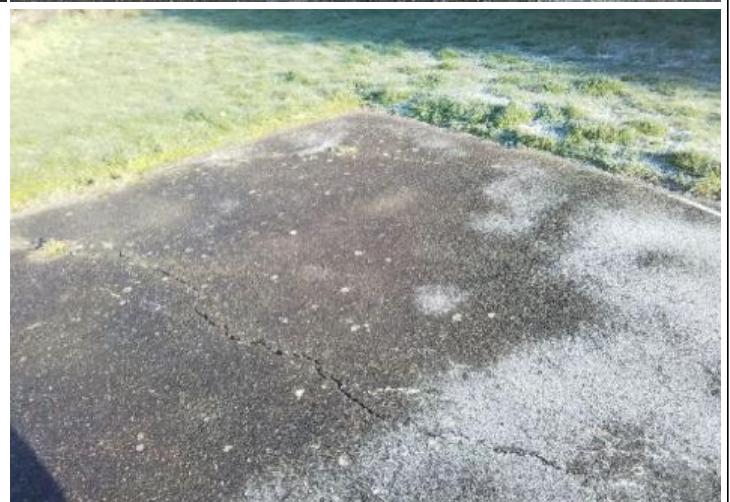
Item: Multi Use Games Area - Basketball Post
Manufacturer: Not Identified

Finding: There is moderate damage to the surface

Action: Repair the damaged areas of surfacing

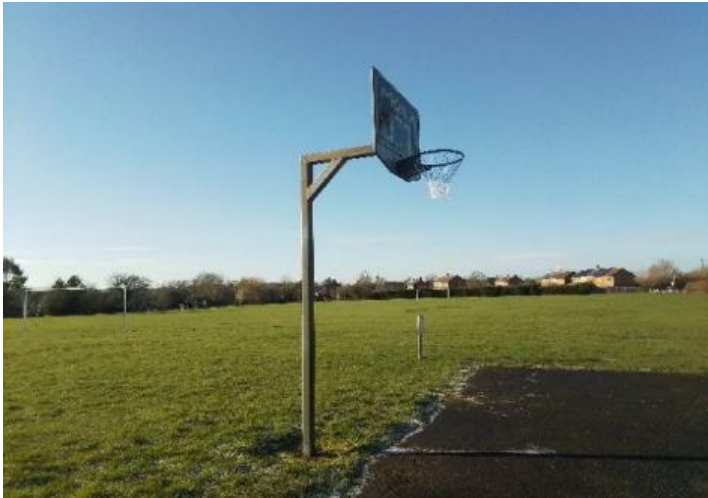
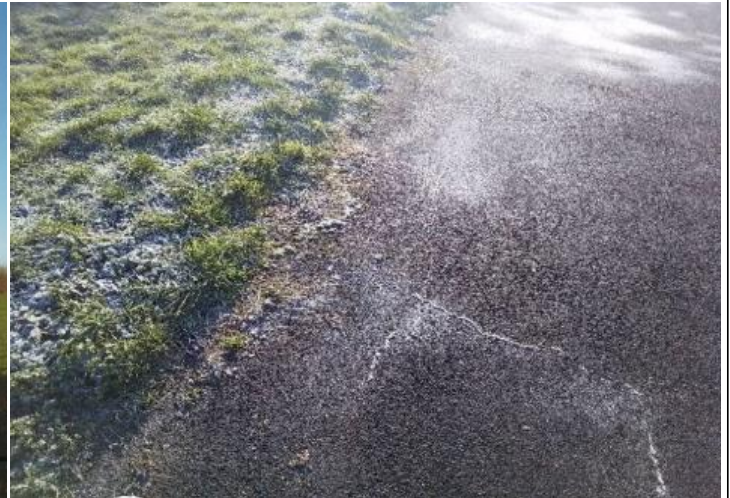
Item: Multi Use Games Area - Basketball Post
Manufacturer: Not Identified

Finding: There is weed / vegetation growth on, between, or around the edges of the surfacing
Action: Remove weed / vegetation growth

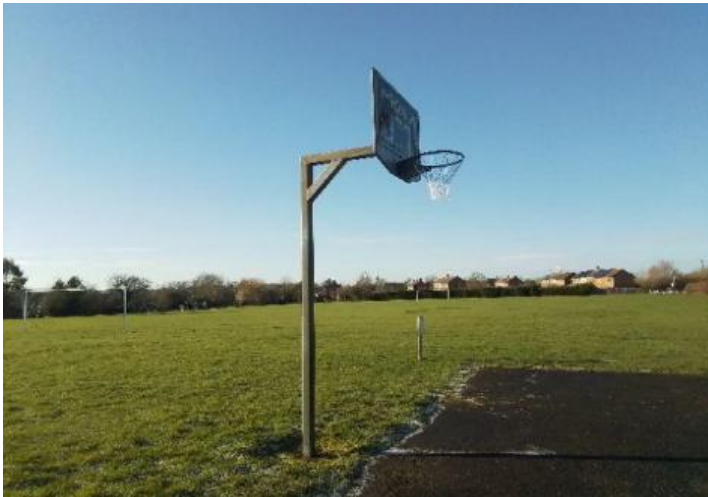
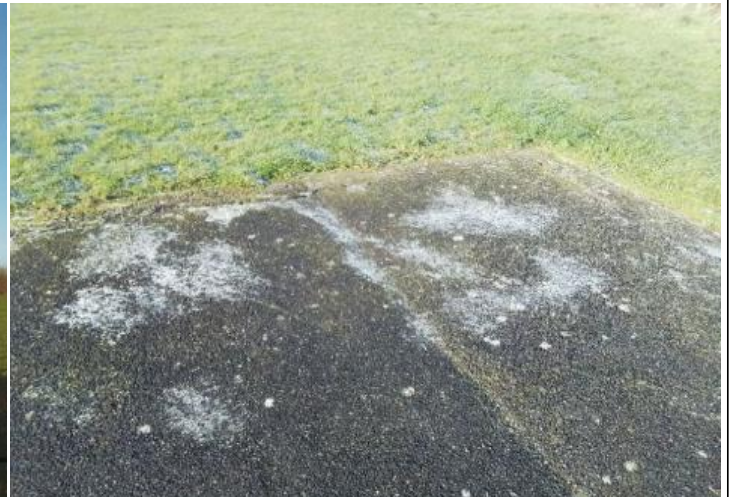
Item: Multi Use Games Area - Basketball Post
Manufacturer: Not Identified

Finding: There is algae, silt or moss growth on the surface resulting in slippery conditions
Action: Clean and treat appropriately

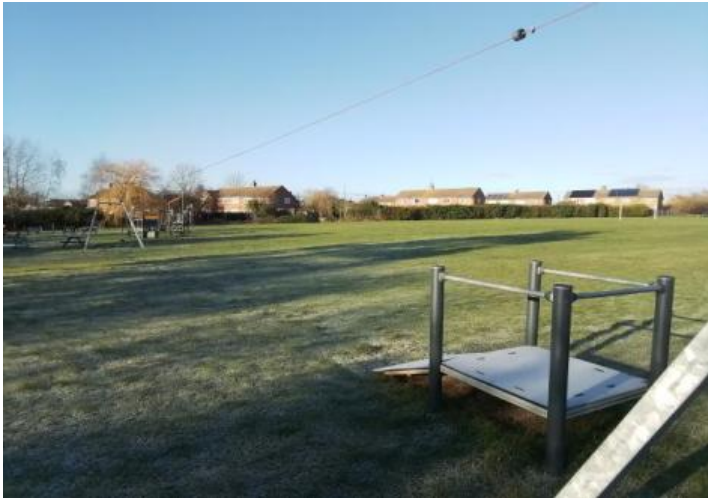
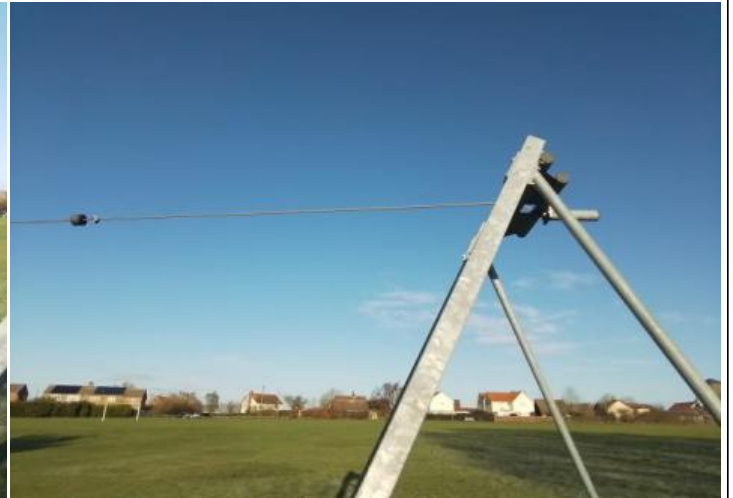
Item: Other - Cable Runway
Manufacturer: Kompan Ltd

Finding: We have completed a visual inspection of the suspension links, cable and fixing points from ground level, however it is not possible to fully inspect these areas without either hiring equipment to gain access or removing the cable and suspension and inspecting at ground level. We recommend that the main cable and fixing security is thoroughly inspected at least in accordance with the manufacturers recommendations to check for wear, damage, security or internal rusting; this will help to ensure the continued safe use of the equipment

Action: Inspect in accordance with the manufacturers recommendations

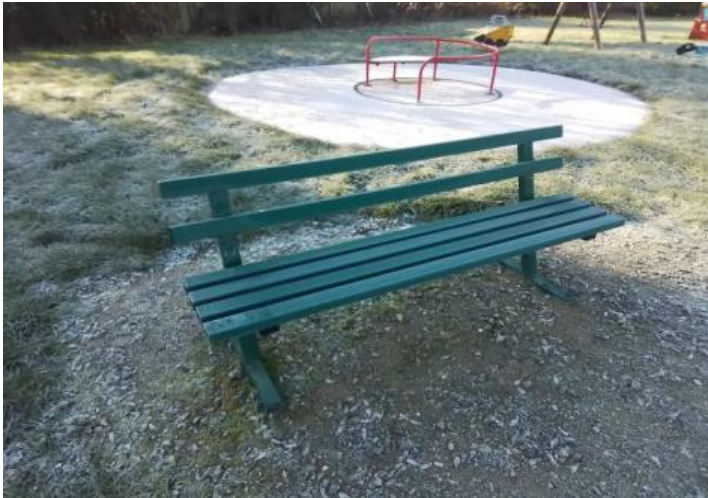
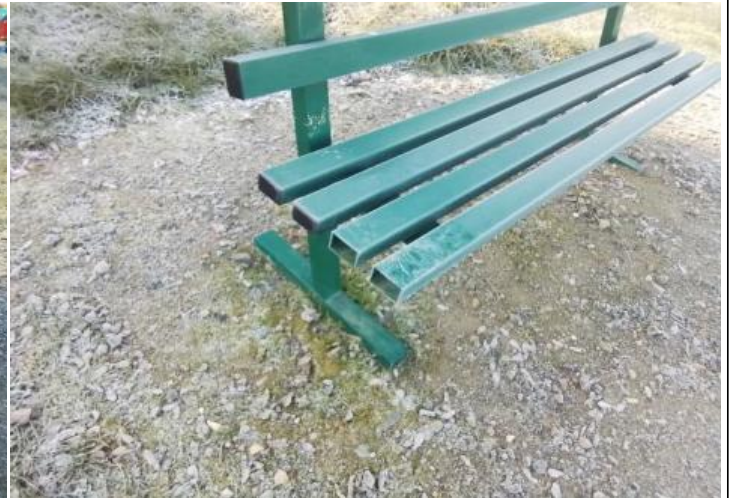
Item: Ancillary Items - Bench
Manufacturer: Not Identified

Finding: There are post / end caps missing from the item

Action: Replace missing post caps
