Annual Inspection

Mid Suffolk District Council

Buxhall

Off Mill Road, Suffolk, IP14 3DS

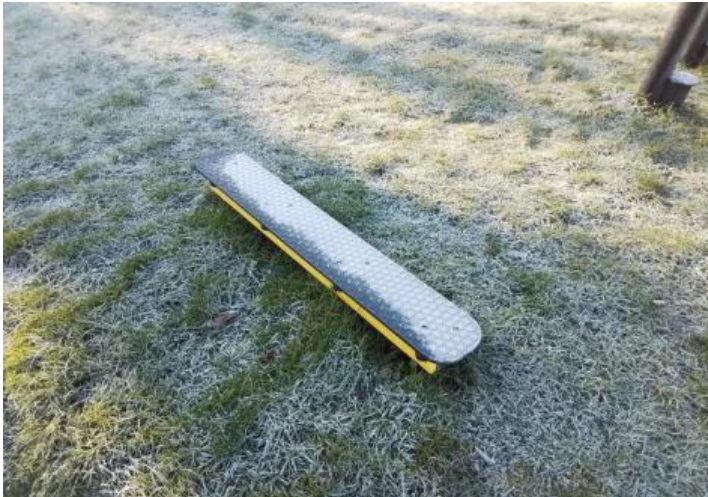
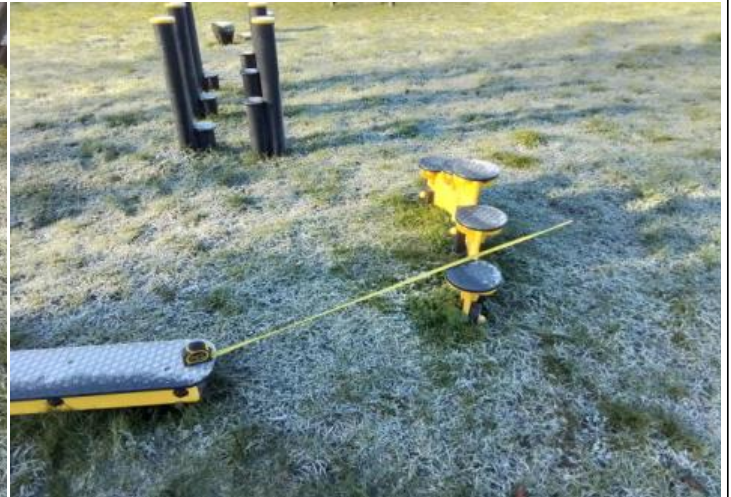
Item: Activity Equipment - Balance Beam
Manufacturer: Kompan Ltd

Finding: The step between the items is quite large and users may not be able to complete the step without touching ground, the items could therefore be considered to be within the falling space of each other, however the intention of the play activity continuity is easily apparent and foreseeable to the user

Action: Monitor - No remedial work recommended

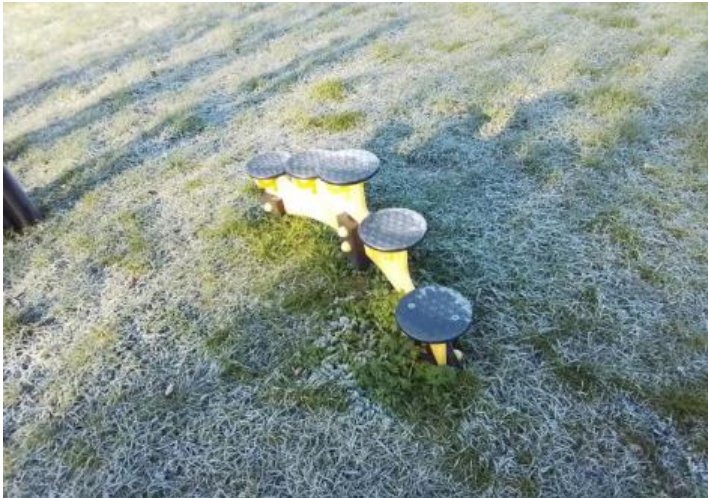
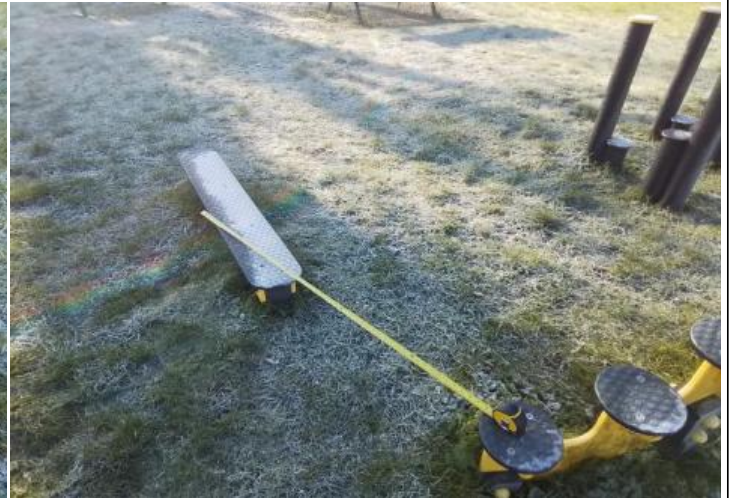
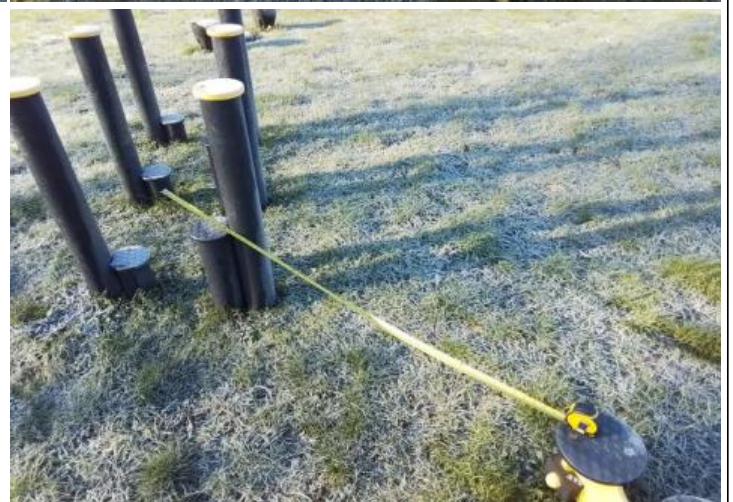
Item: Activity Equipment - Balance Beam
Manufacturer: Kompan Ltd

Finding: The step between the items is quite large and users may not be able to complete the step without touching ground, the items could therefore be considered to be within the falling space of each other, however the intention of the play activity continuity is easily apparent and foreseeable to the user

Action: Monitor - No remedial work recommended

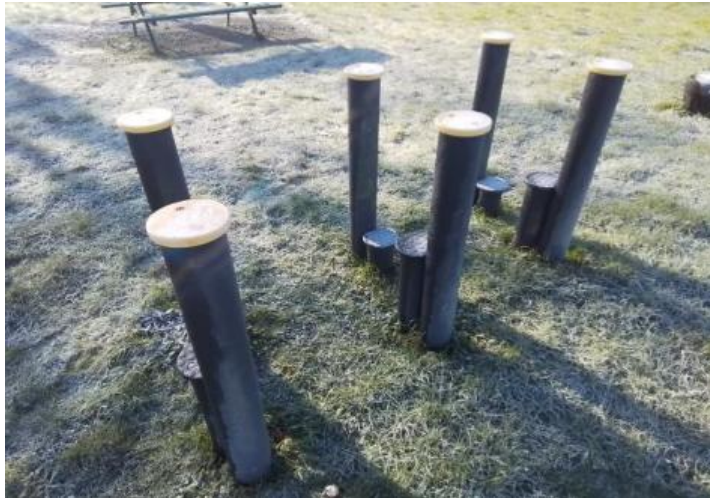
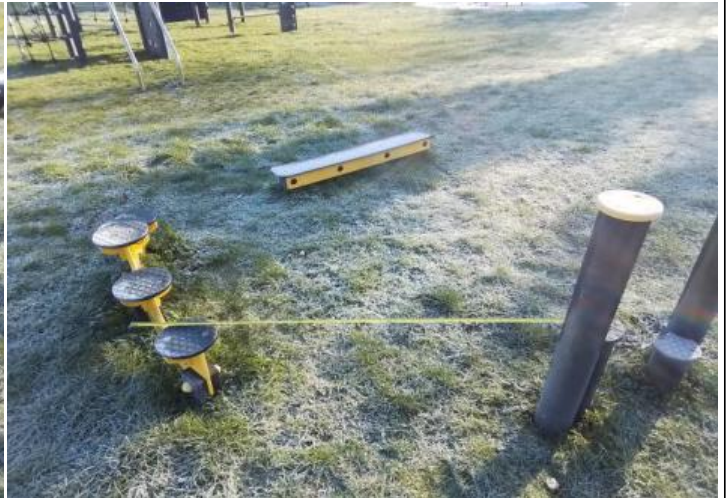
Item: Activity Equipment - Stilts
Manufacturer: Kompan Ltd

Finding: The step between the items is quite large and users may not be able to complete the step without touching ground, the items could therefore be considered to be within the falling space of each other, however the intention of the play activity continuity is easily apparent and foreseeable to the user

Action: Monitor - No remedial work recommended
