the **play inspection** company

Annual Inspection

Mid Suffolk District Council

Buxhall

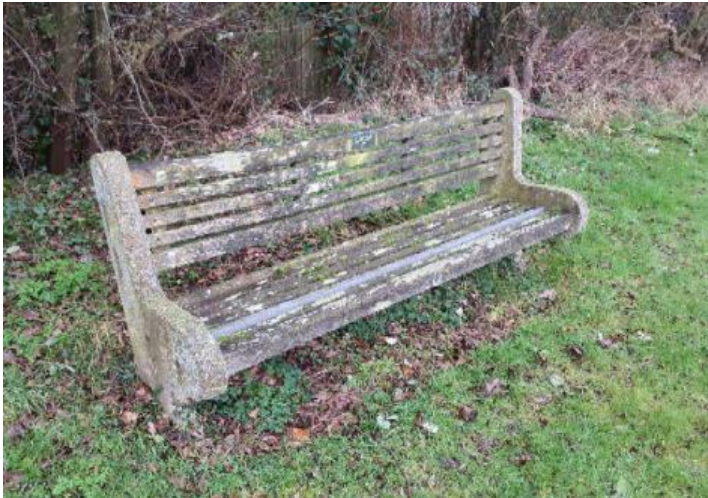
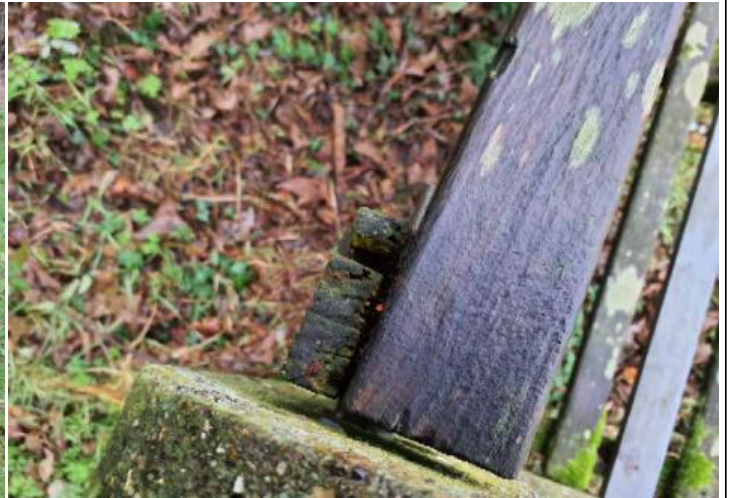
Item: Ancillary Items - Bench
Manufacturer: Not Identified

Finding: There is some evidence of rot in the timber

Action: Monitor for any further deterioration and replace as required

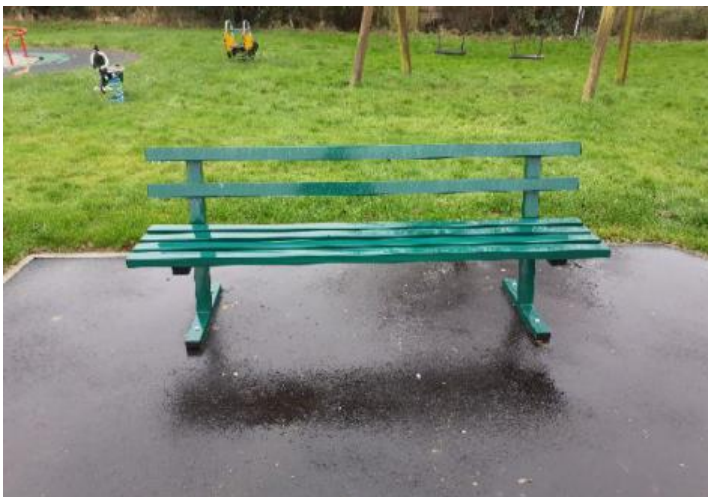
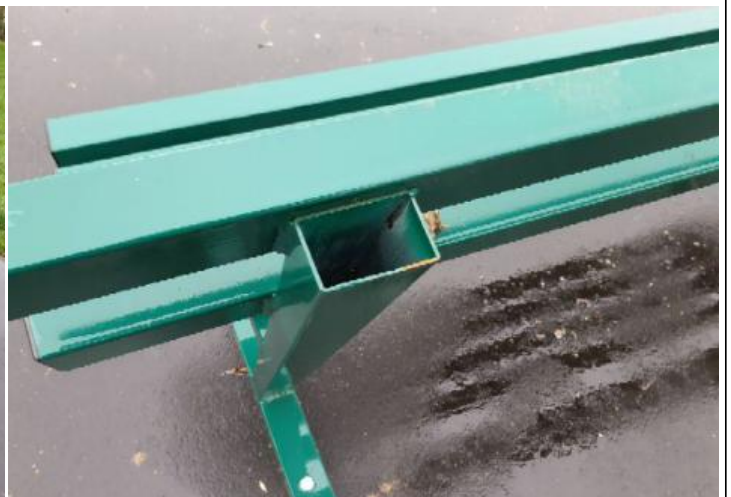
Item: Ancillary Items - Bench
Manufacturer: Not Identified

Finding: There are post / end caps missing from the item

Action: Replace missing post caps

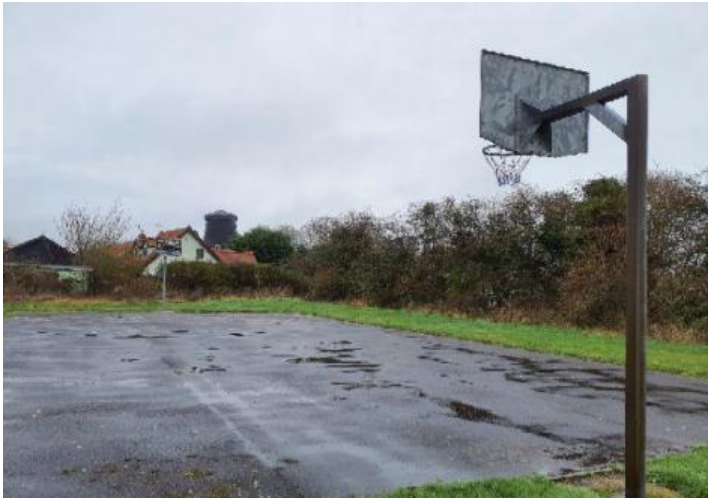
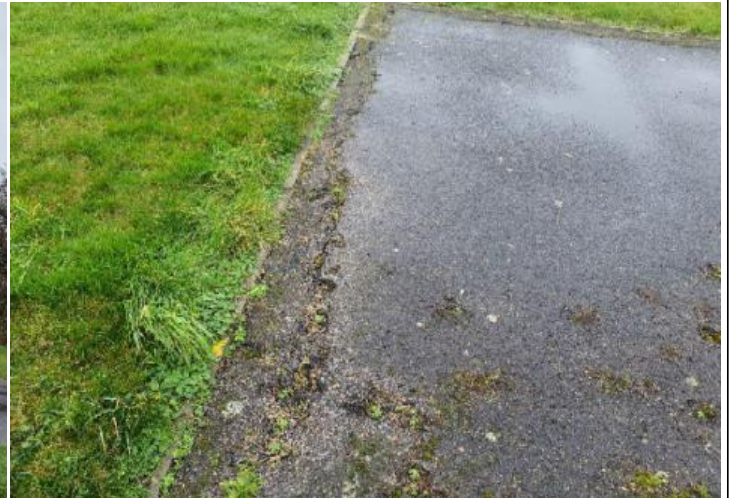
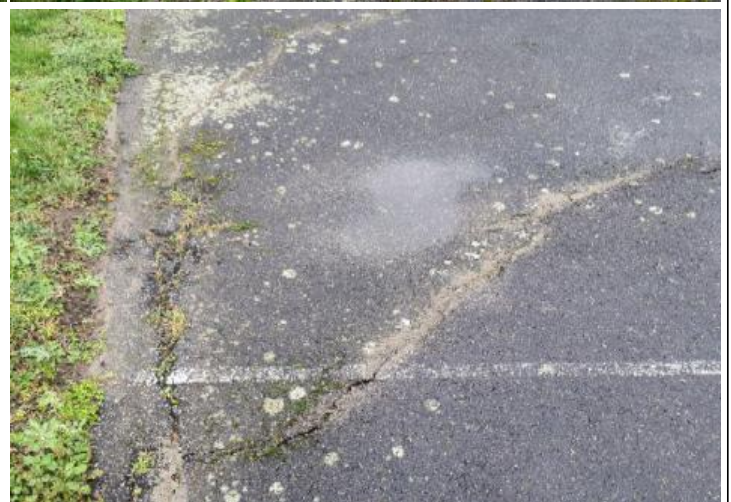
Item: Multi Use Games Area - Basketball Post
Manufacturer: Not Identified

Finding: There is moderate damage to the surface

Action: Repair the damaged areas of surfacing

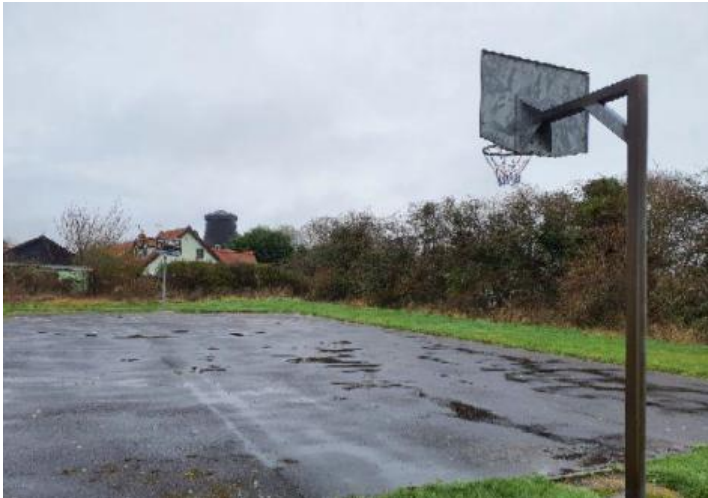
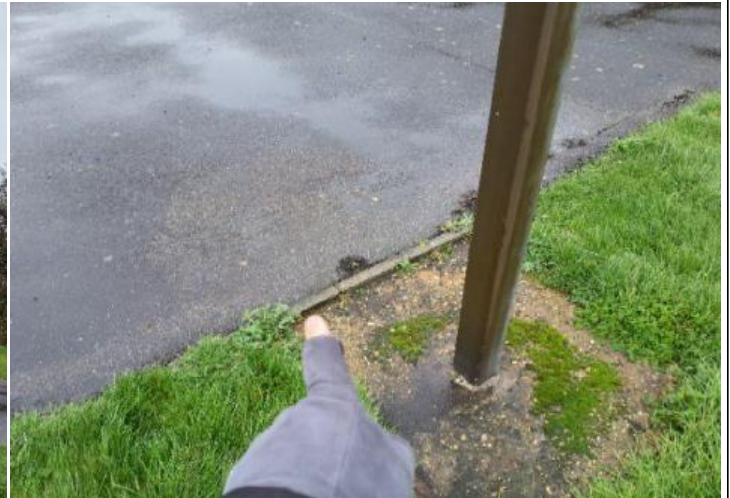
Item: Multi Use Games Area - Basketball Post
Manufacturer: Not Identified

Finding: There are trip hazards at the edges of the surface **Action:** Remove the trip points

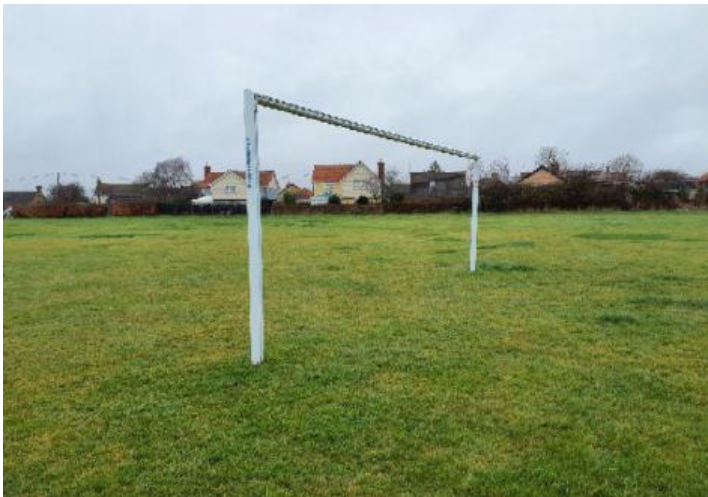
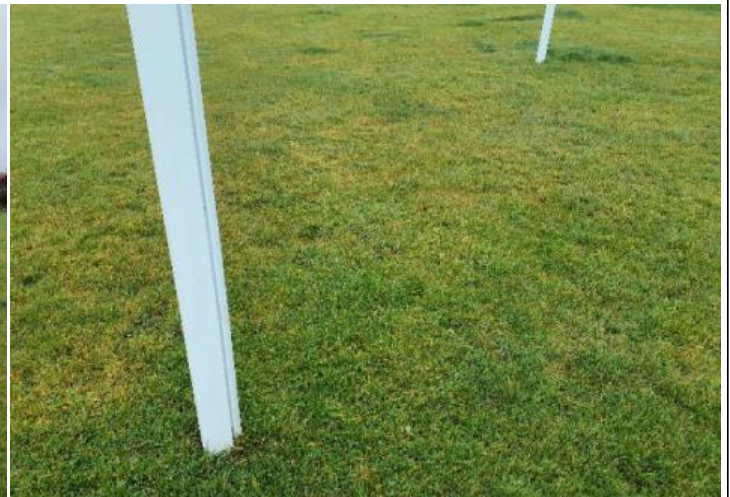
Item: Multi Use Games Area - Football Goal
Manufacturer: Not Identified

Finding: The item is slightly loose in its foundations

Action: Monitor for any further deterioration and repair as required

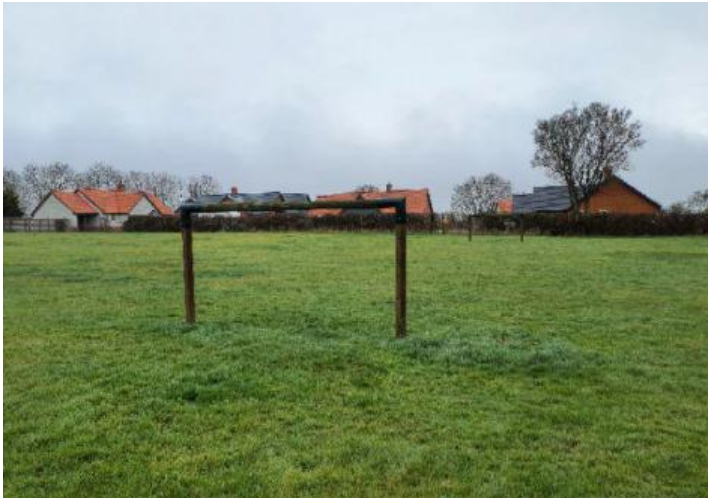
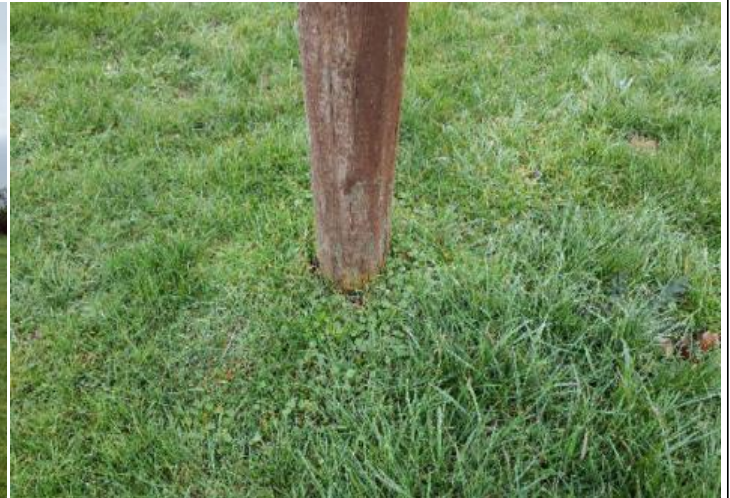
Item: Multi Use Games Area - Goal End
Manufacturer: Not Identified

Finding: There is some strimmer / machinery damage apparent on the posts, this can penetrate the preservative applied to the timber and accelerate the rotting process

Action: Monitor for any deterioration (rot) and replace as required

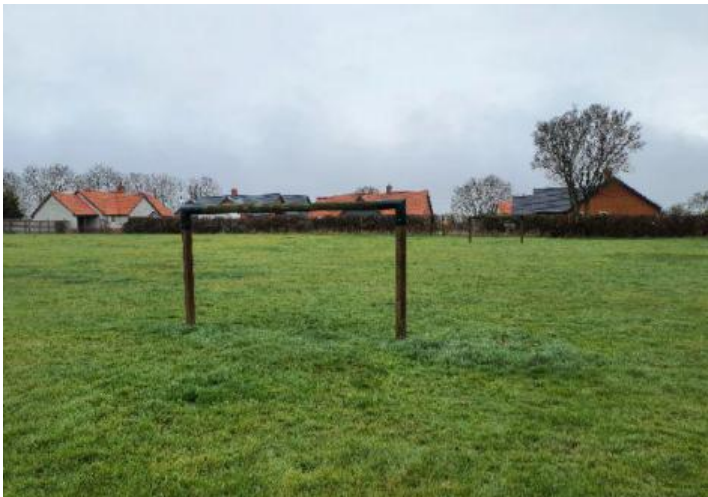
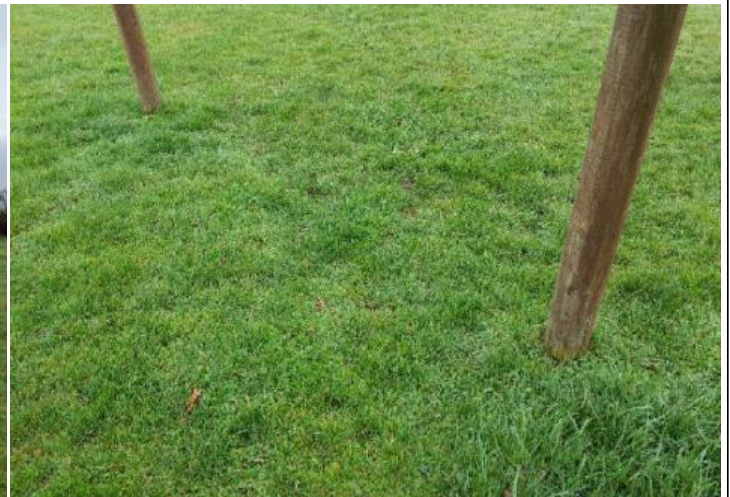
Item: Multi Use Games Area - Goal End
Manufacturer: Not Identified

Finding: There is some evidence of rot in the timber

Action: Monitor for any further deterioration and replace as required

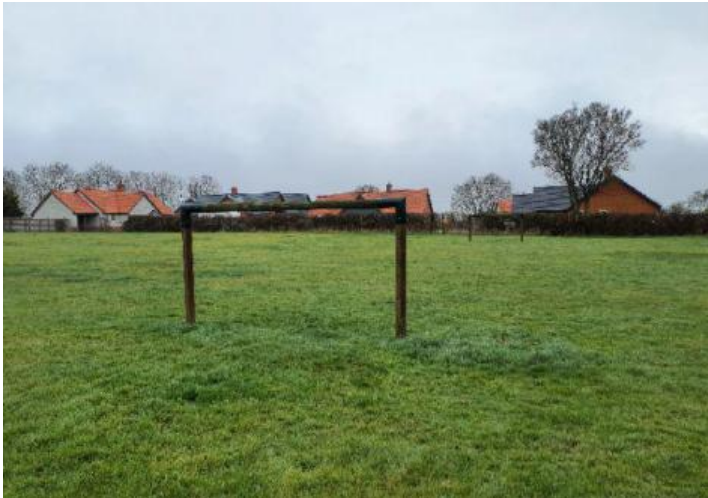
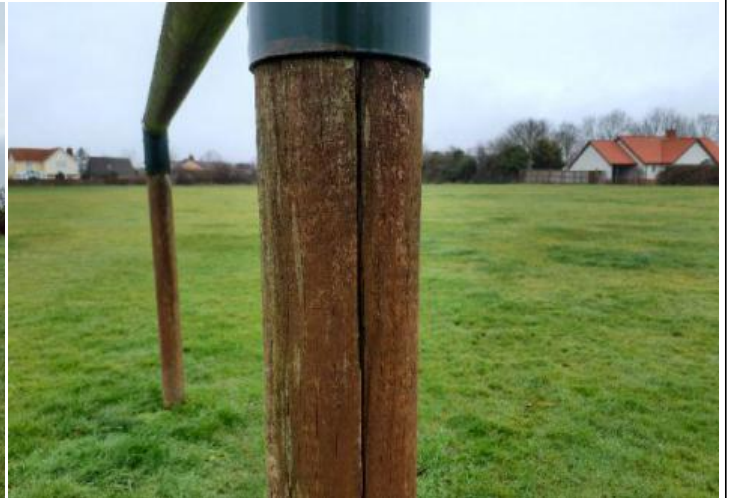
Item: Multi Use Games Area - Goal End
Manufacturer: Not Identified

Finding: The timber has a number of splits/shakes or air cracks and this may affect the stability or allow water ingress which will accelerate the rotting process
Action: Monitor to ensure the splits do not cross through fixing points of the structure and/or cause any instability

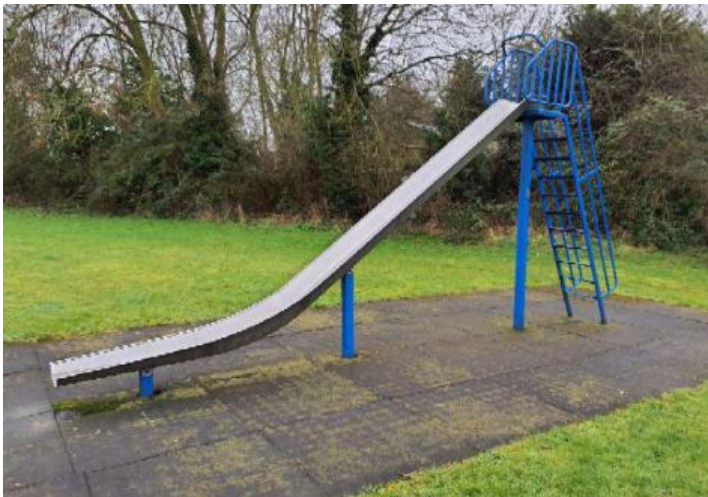
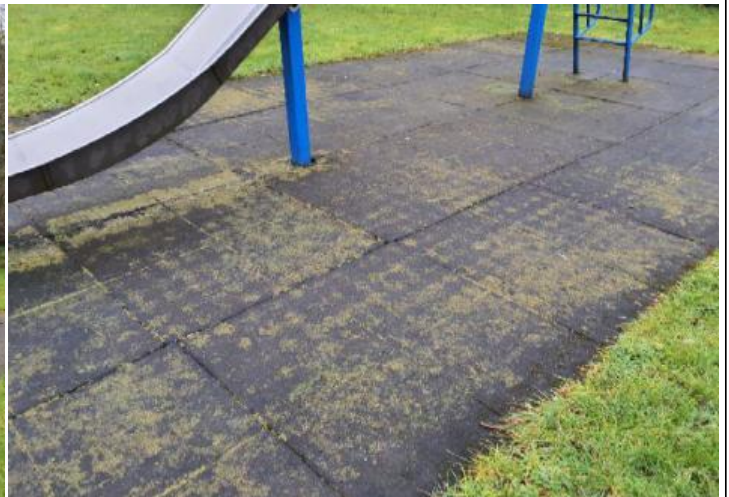
Item: Other - Free Standing Slide
Manufacturer: Wicksteed Playgrounds

Finding: There is algae, silt or moss growth on the surface resulting in slippery conditions
Action: Clean and treat appropriately

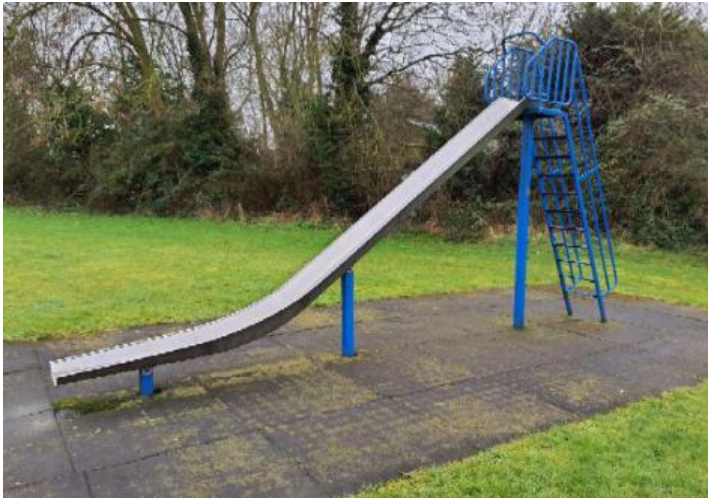
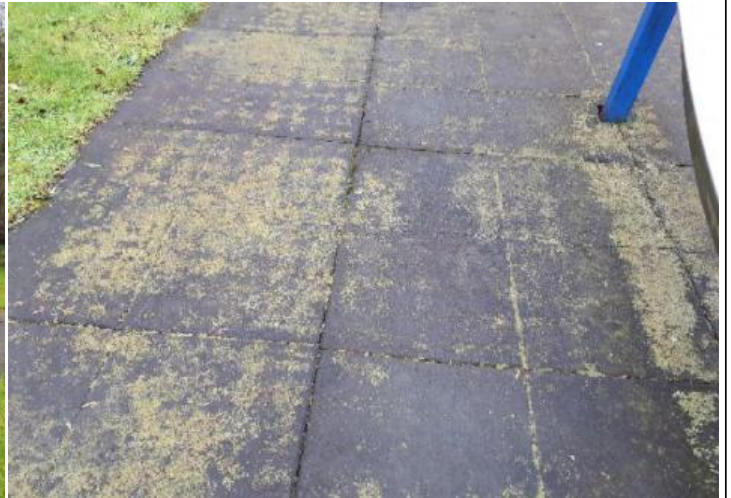
Item: Other - Free Standing Slide
Manufacturer: Wicksteed Playgrounds

Finding: There are gaps opening in between the tiles

Action: Monitor for any further deterioration and repair as required

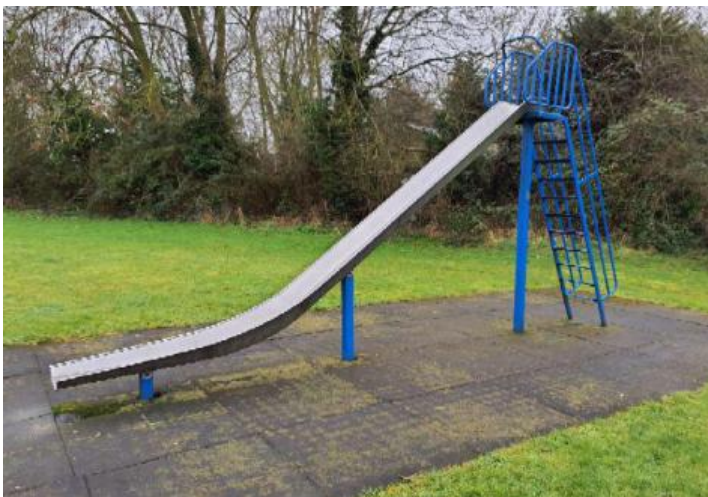
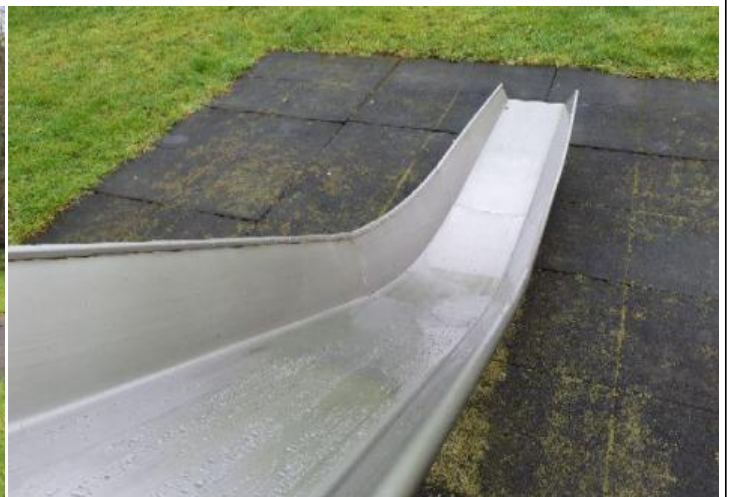
Item: Other - Free Standing Slide
Manufacturer: Wicksteed Playgrounds

Finding: There are a number of dents in the slide surface

Action: Monitor for any further deterioration and repair as required

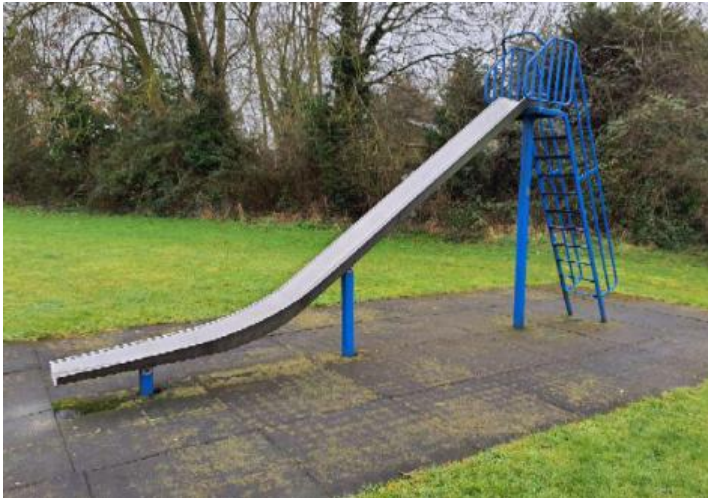
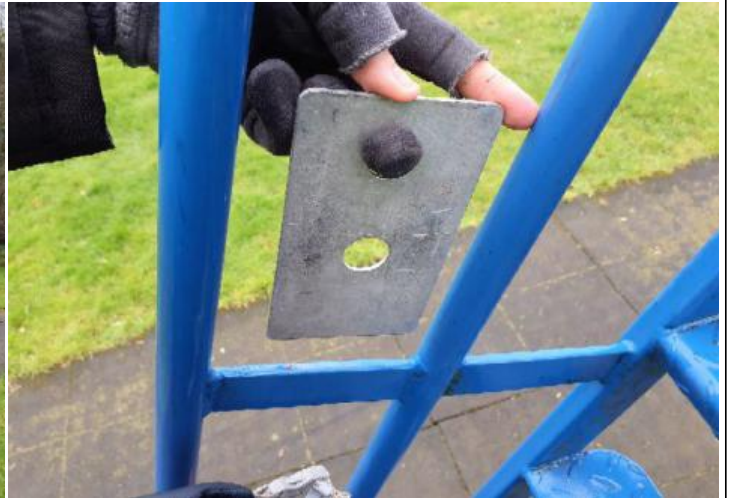
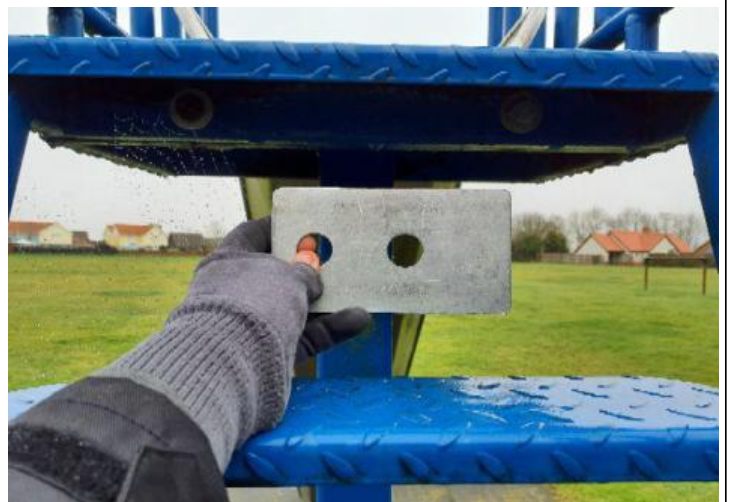
Item: Other - Free Standing Slide
Manufacturer: Wicksteed Playgrounds

Finding: The item fails to meet the requirements of BS EN 1176 Part 1 4.2.7.2 head and neck entrapment in the barriers and/or steps

Action: Monitor - No remedial work recommended

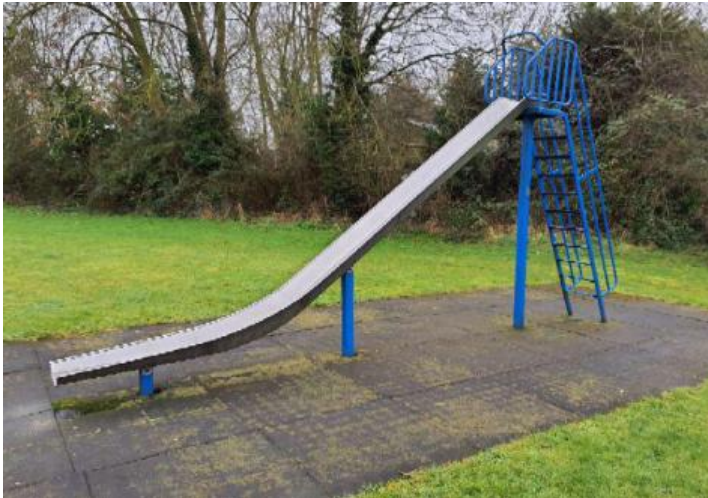
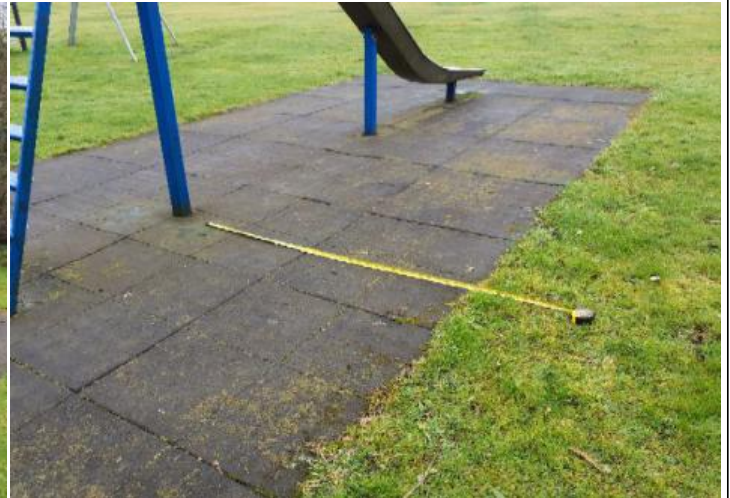
Item: Other - Free Standing Slide
Manufacturer: Wicksteed Playgrounds

Finding: The surfacing dimensions are short and do not meet with the requirements of the current applicable standard

Action: Monitor - no remedial action recommended

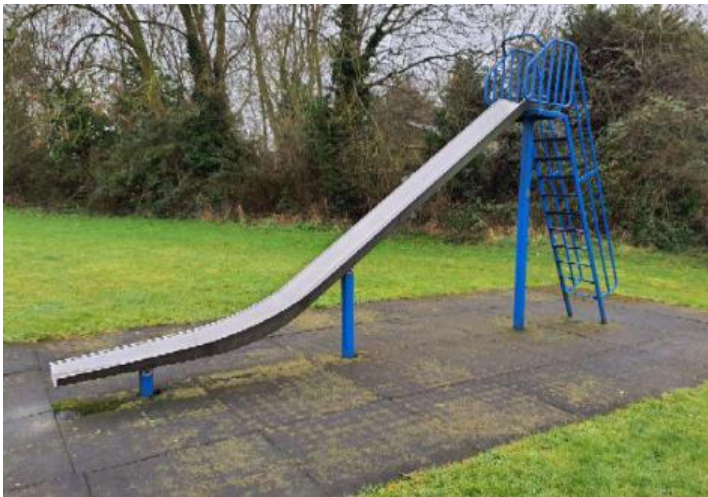
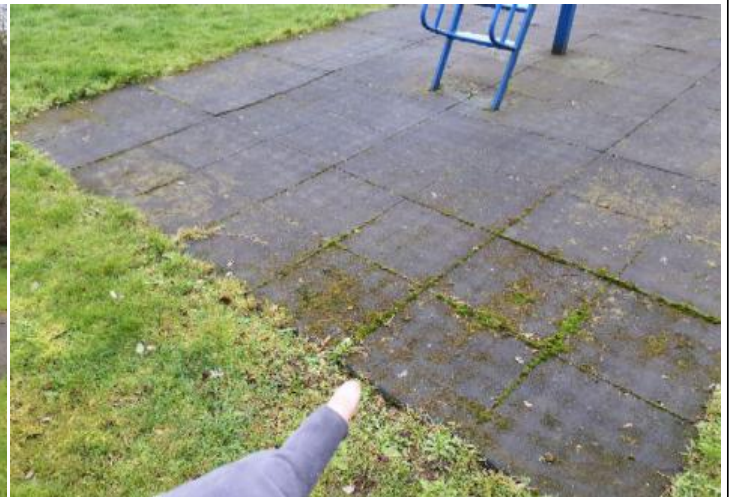
Item: Other - Free Standing Slide
Manufacturer: Wicksteed Playgrounds

Finding: There are trip hazards at the edges of the surface

Action: Reinstate surrounding surface levels to remove the trip points

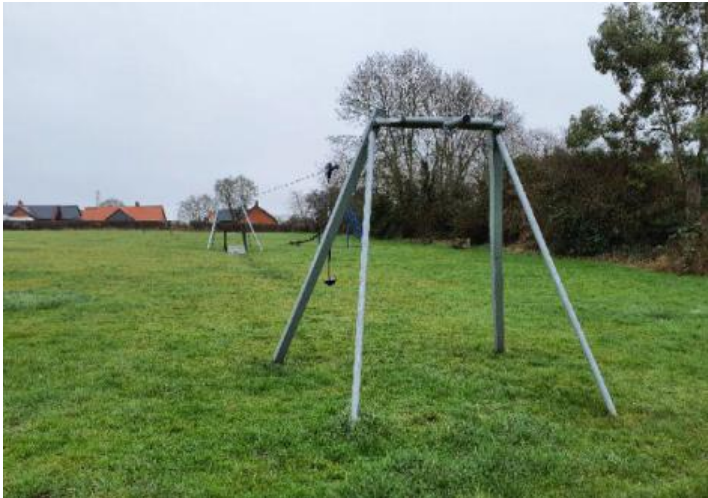
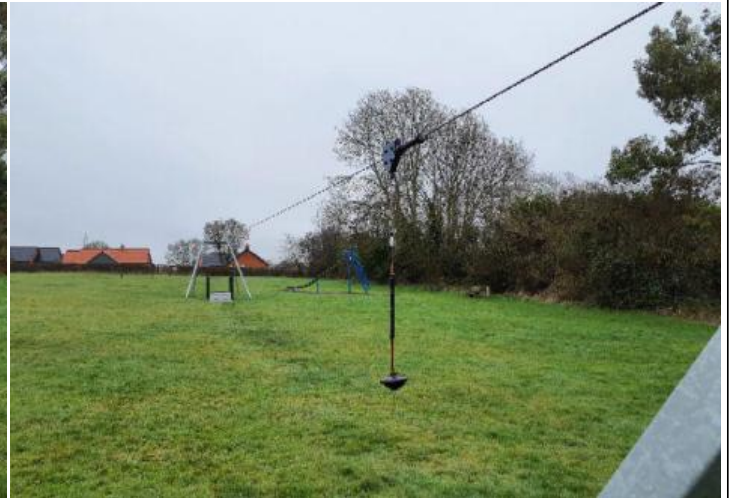
Item: Other - Cable Runway
Manufacturer: Kompan Ltd

Finding: We have completed a visual inspection of the suspension links, cable and fixing points from ground level, however it is not possible to fully inspect these areas without either hiring equipment to gain access or removing the cable and suspension and inspecting at ground level. We recommend that the main cable and fixing security is thoroughly inspected at least in accordance with the manufacturers recommendations to check for wear, damage, security or internal rusting; this will help to ensure the continued safe use of the equipment

Action: Inspect in accordance with the manufacturers recommendations

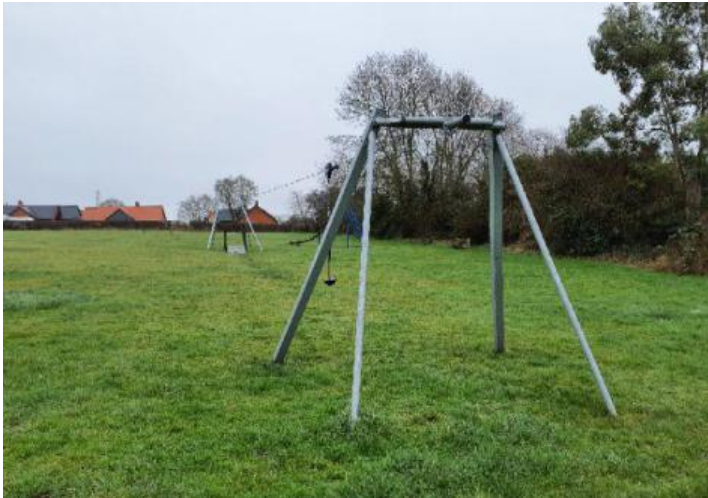
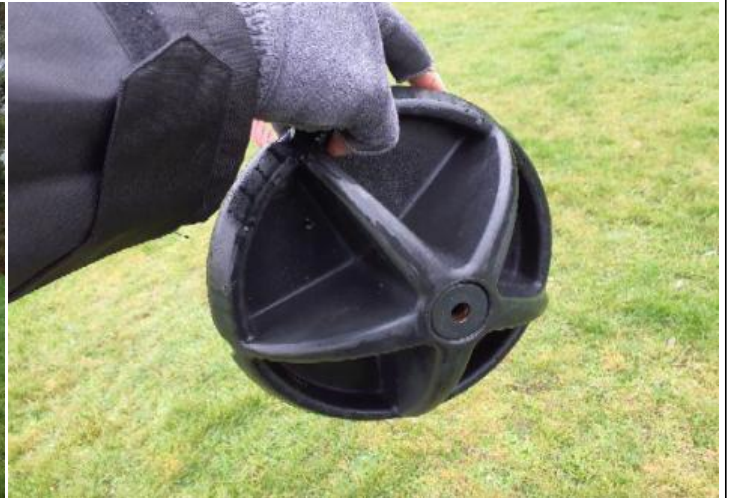
Item: Other - Cable Runway
Manufacturer: Kompan Ltd

Finding: The seat connection cannot be inspected without dismantling the seat

Action: Dismantle the seat to inspect the seat connection for wear

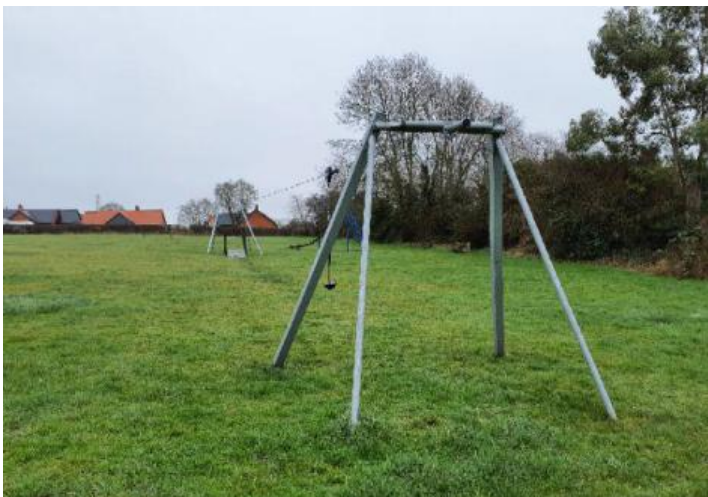
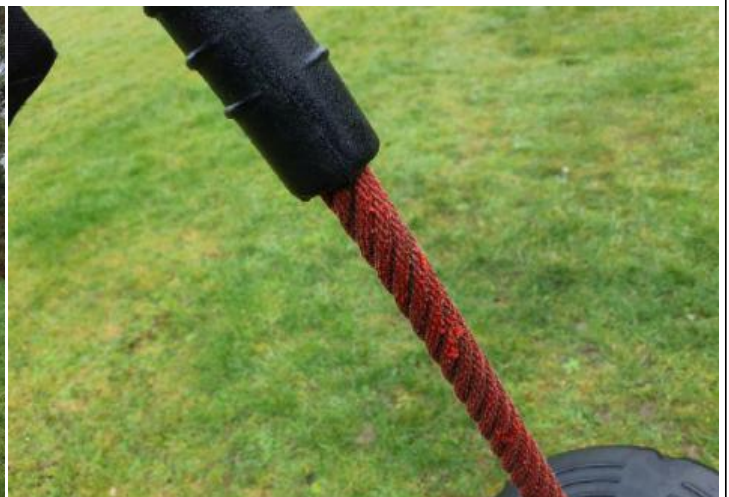
Item: Other - Cable Runway
Manufacturer: Kompan Ltd

Finding: The ropes/nets are worn/damaged in places

Action: Monitor for any further deterioration and repair or replace as required

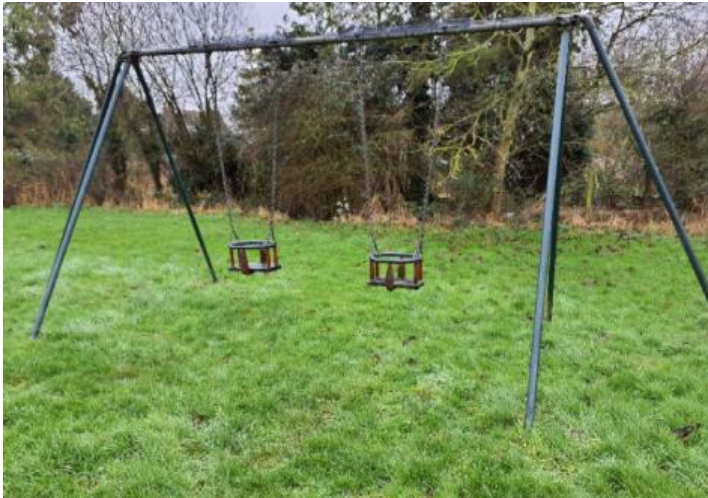
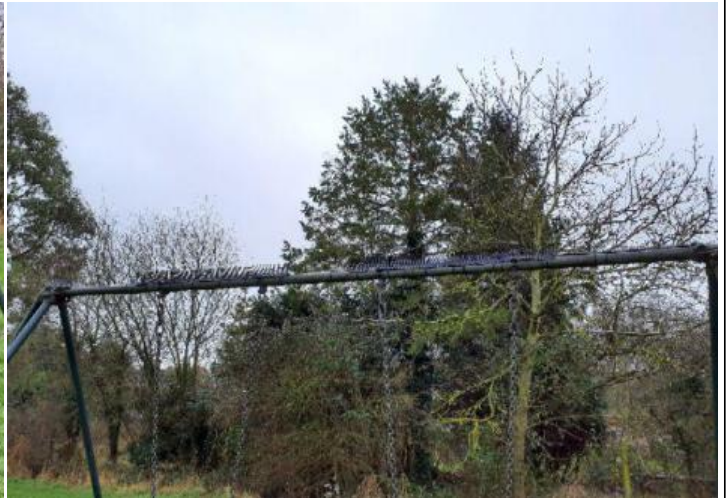
Item: Swings - 1 Bay 2 Seat (Cradle)
Manufacturer: Not Identified

Finding: We do not recommend the installation of anti bird devices on equipment

Action: Remove and replace with upturned cable ties

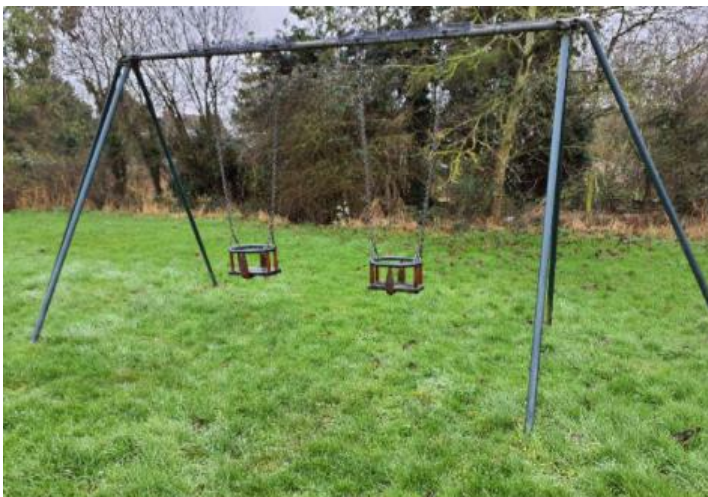
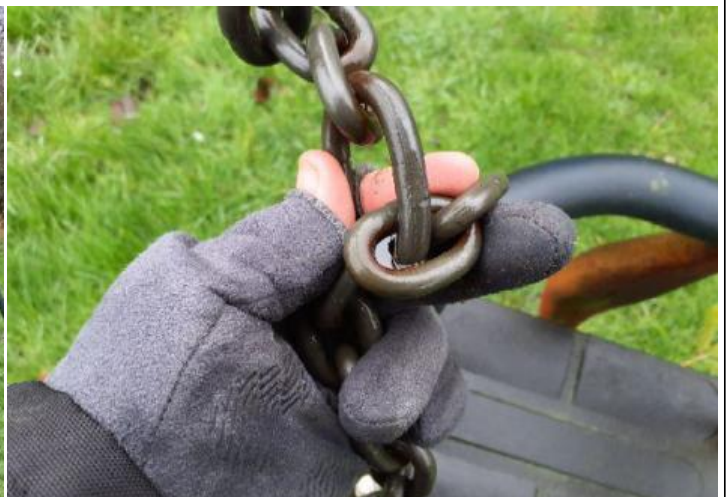
Item: Swings - 1 Bay 2 Seat (Cradle)
Manufacturer: Not Identified

Finding: There is some notable evidence of chain wear

Action: Monitor for any further deterioration and replace when 40% worn

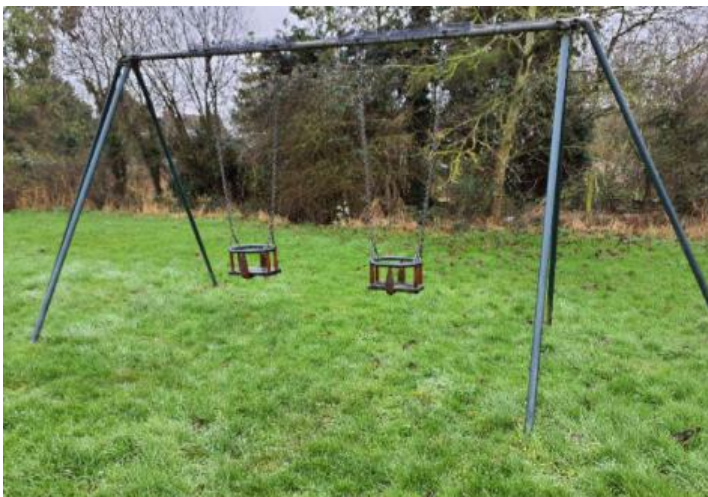
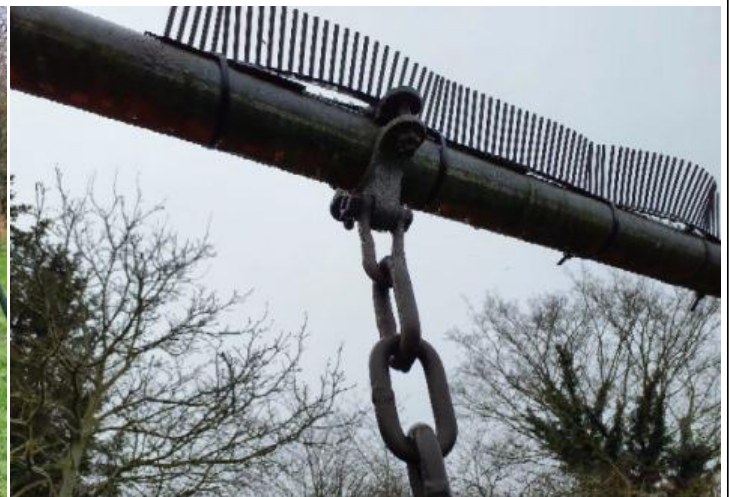
Item: Swings - 1 Bay 2 Seat (Cradle)
Manufacturer: Not Identified

Finding: There is some wear to the shackles

Action: Monitor for any further deterioration and replace when 40% worn

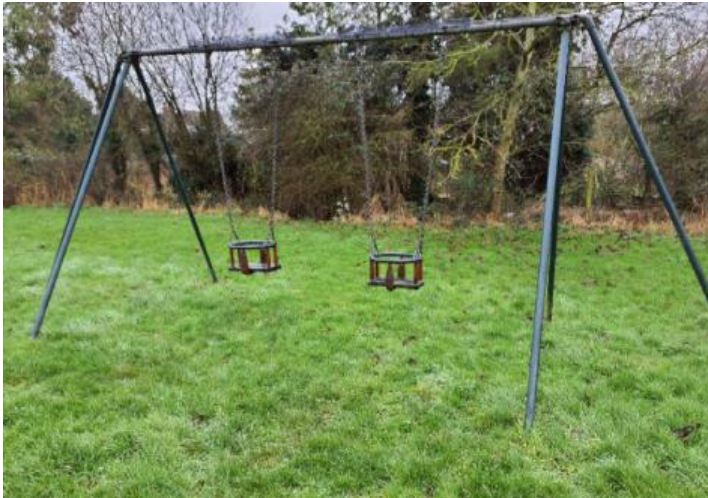
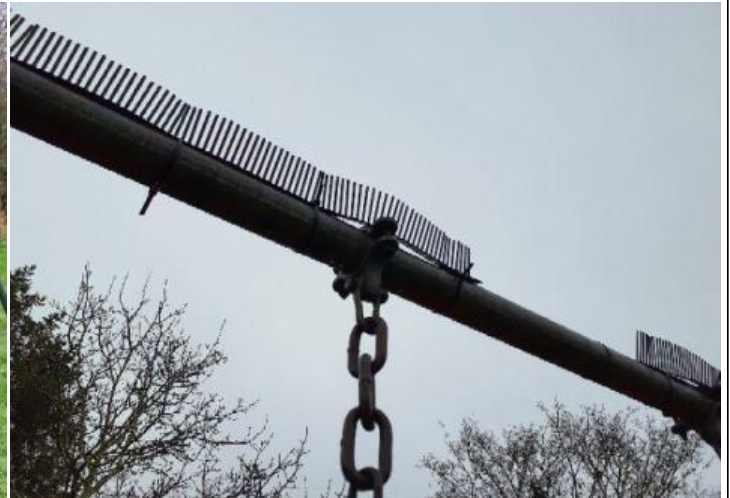
Item: Swings - 1 Bay 2 Seat (Cradle)
Manufacturer: Not Identified

Finding: The bushes are showing signs of wear

Action: Monitor for any further deterioration and replace as required

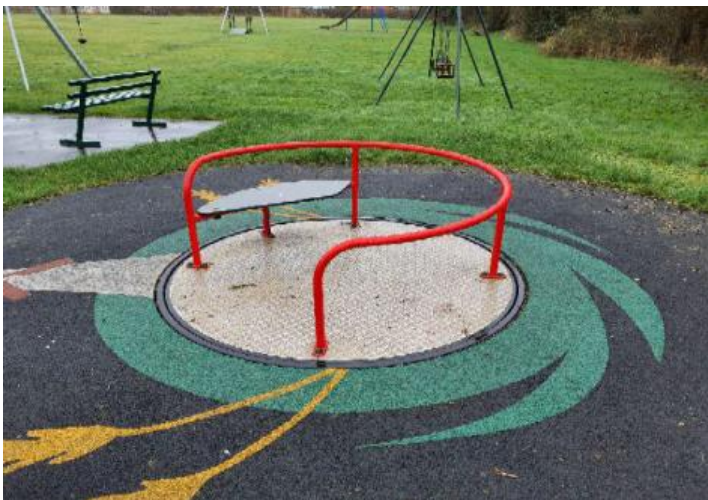
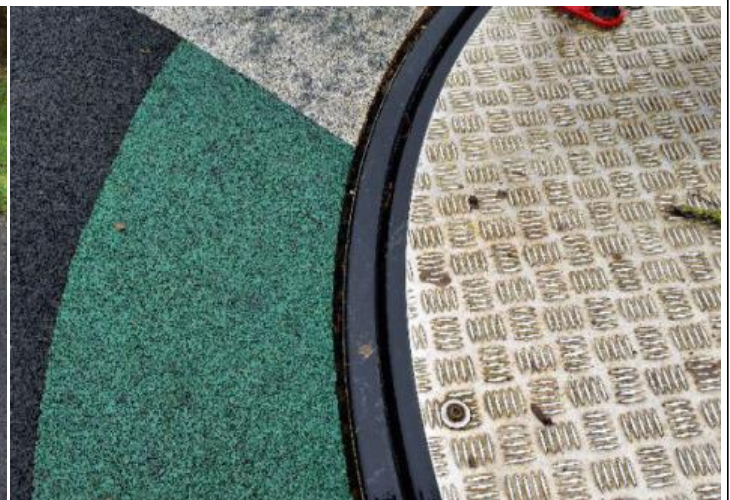
Item: Rotor Play - Inclusive Roundabout
Manufacturer: Kompan Ltd

Finding: There are gaps opening between the surfacing and the edging surround or between the joints in the surfacing

Action: Monitor for any further deterioration and repair as required

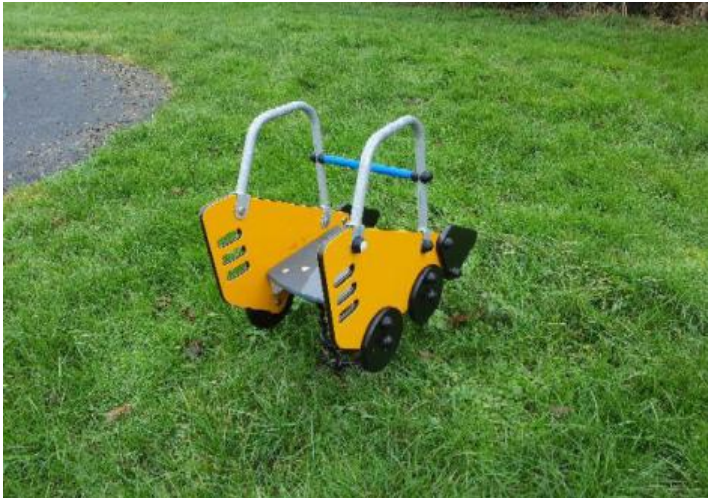
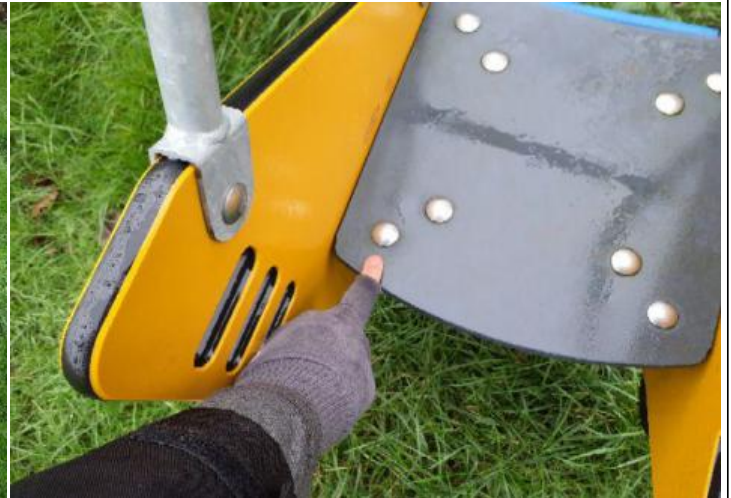
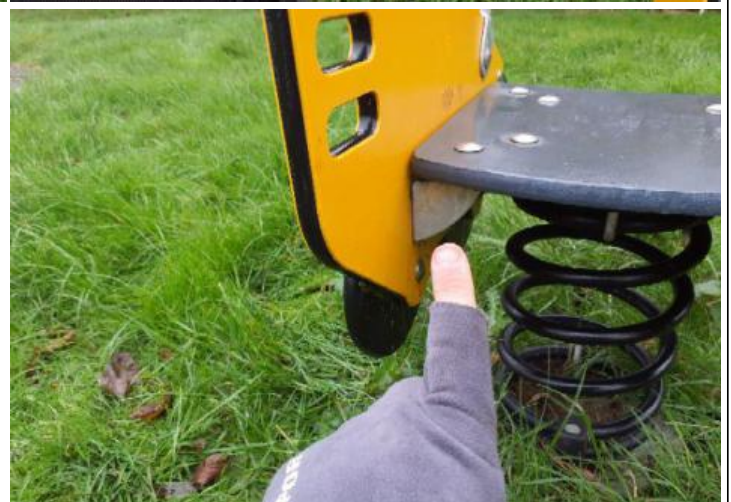
Item: Rocking Equipment - Spring Tractor
Manufacturer: Kompan Ltd

Finding: A number of fixing(s) have worked loose

Action: Secure all loose fixings

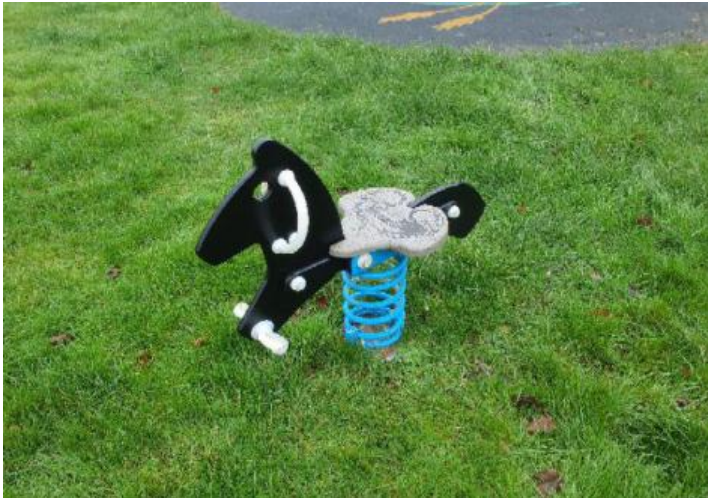
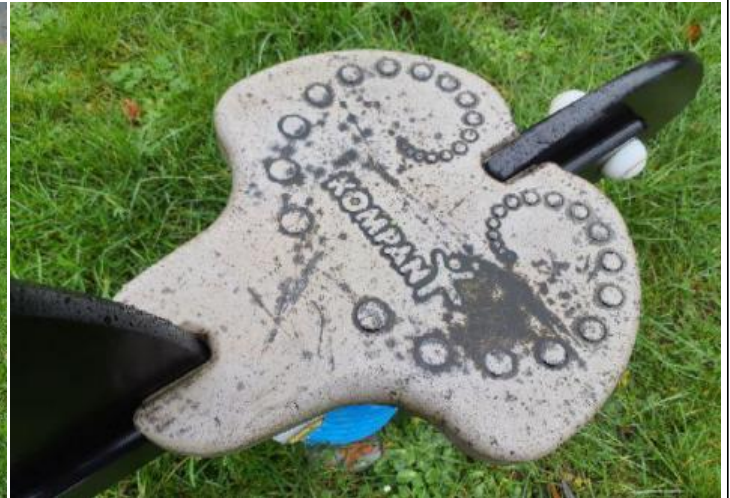
Item: Rocking Equipment - Spring Horse
Manufacturer: Kompan Ltd

Finding: There is some damage to the item

Action: Monitor for any further deterioration and repair as required

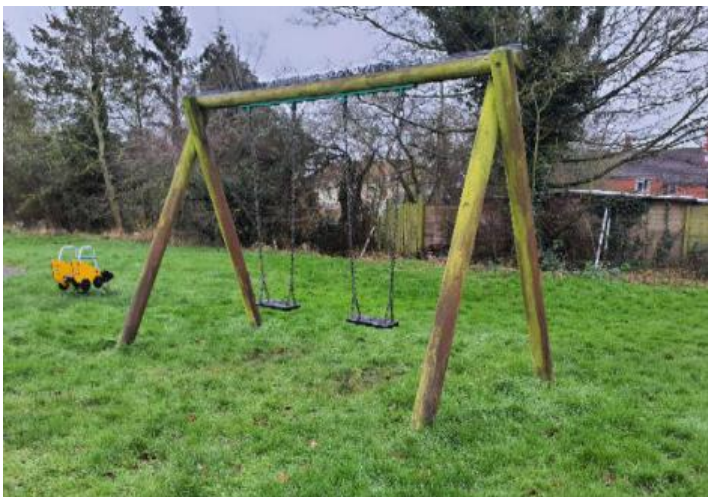
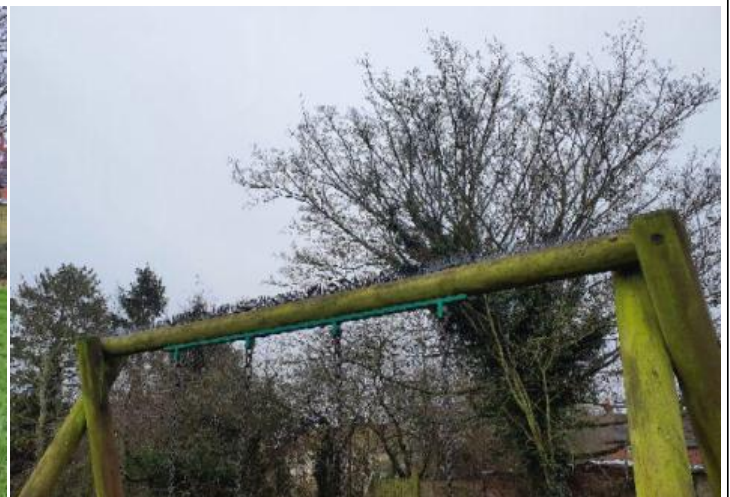
Item: Swings - 1 Bay 2 Seat (Flat)
Manufacturer: A.E.Evans

Finding: We do not recommend the installation of anti bird devices on equipment

Action: Remove and replace with upturned cable ties

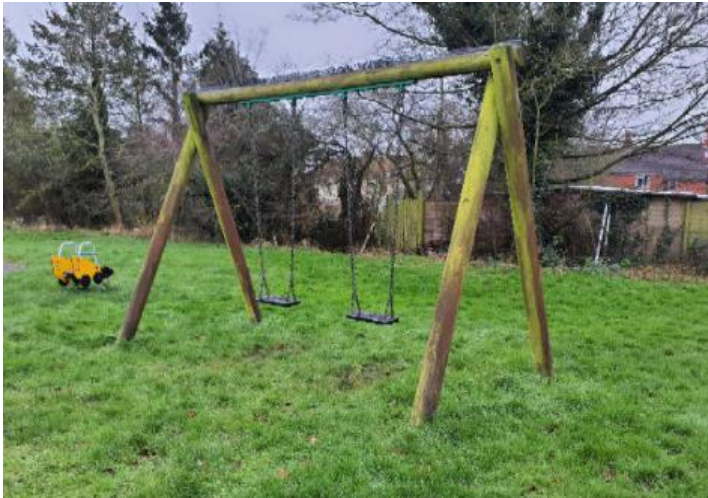
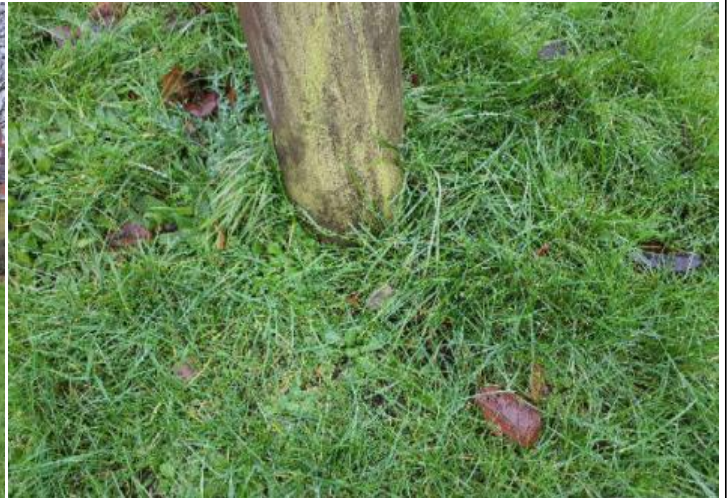
Item: Swings - 1 Bay 2 Seat (Flat)
Manufacturer: A.E.Evans

Finding: There is some strimmer / machinery damage apparent on the posts, this can penetrate the preservative applied to the timber and accelerate the rotting process

Action: Monitor for any deterioration (rot) and replace as required

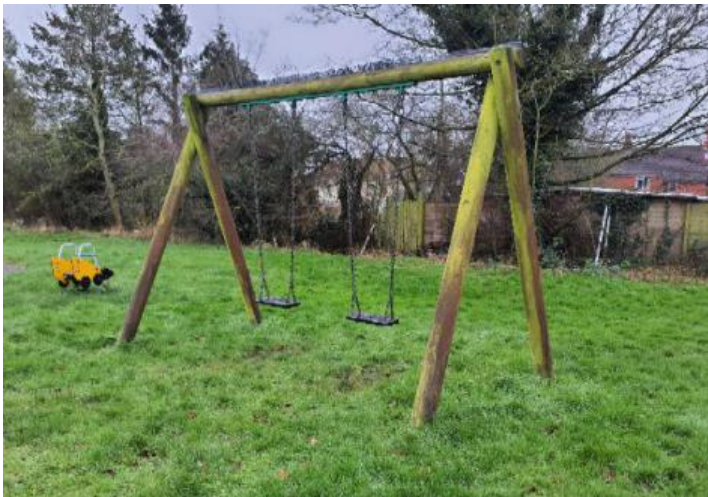
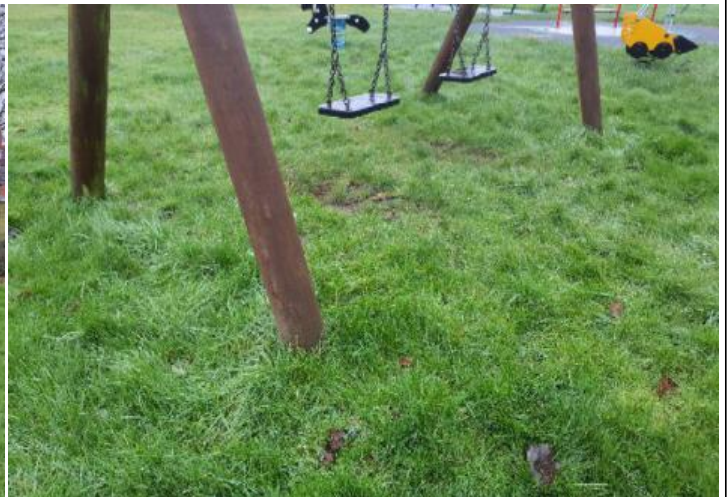
Item: Swings - 1 Bay 2 Seat (Flat)
Manufacturer: A.E.Evans

Finding: There is some evidence of rot in the timber

Action: Monitor for any further deterioration and replace as required

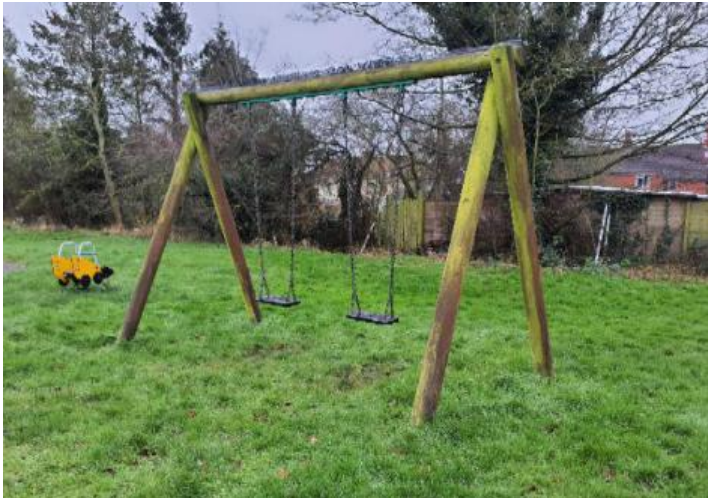
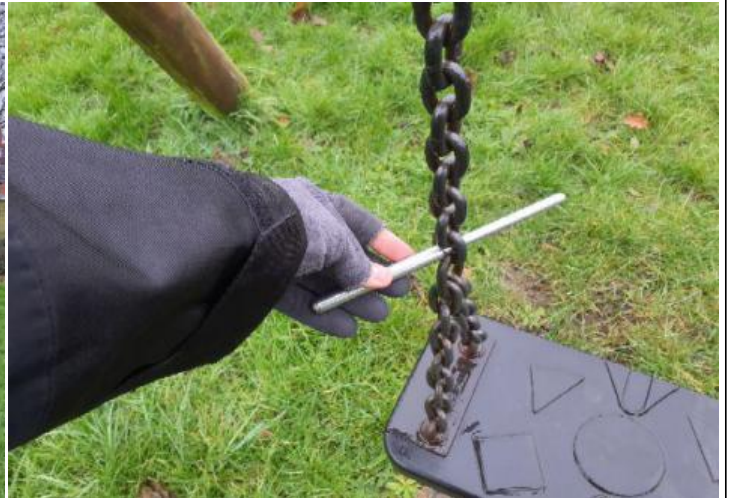
Item: Swings - 1 Bay 2 Seat (Flat)
Manufacturer: A.E.Evans

Finding: The chain openings are in excess of 8.6mm and do not meet the recommendations of BS EN 1176 Part 1

Action: Monitor - No remedial work recommended
