the **play inspection** company

Annual Inspection

Mid Suffolk District Council

Buxhall

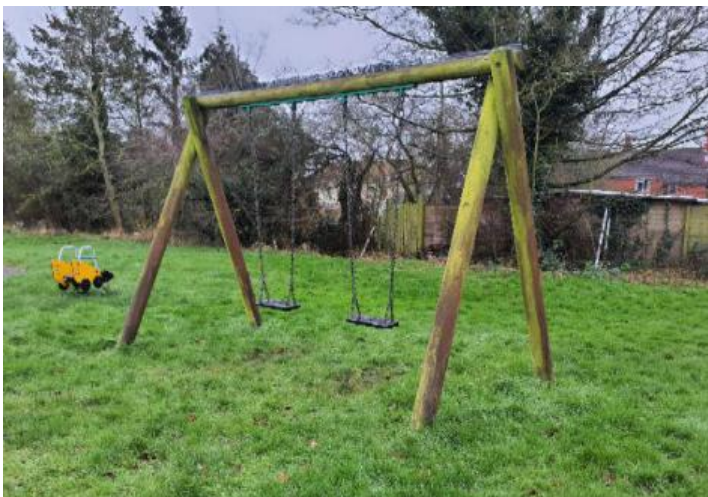
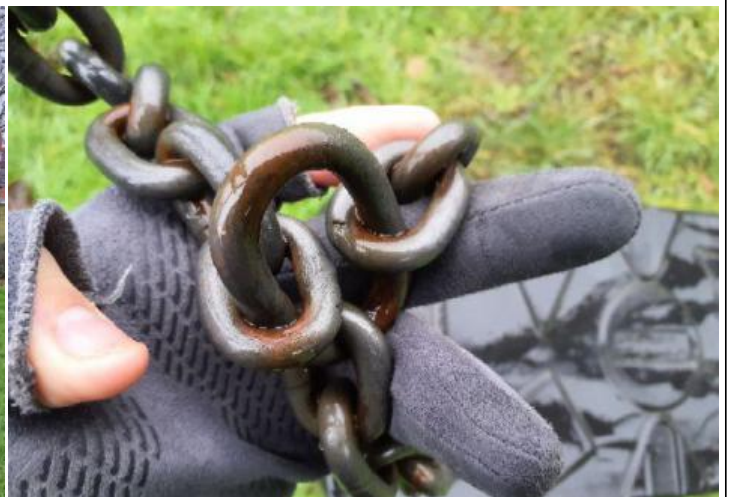
Item: Swings - 1 Bay 2 Seat (Flat)
Manufacturer: A.E.Evans

Finding: There is some notable evidence of chain wear

Action: Monitor for any further deterioration and replace when 40% worn

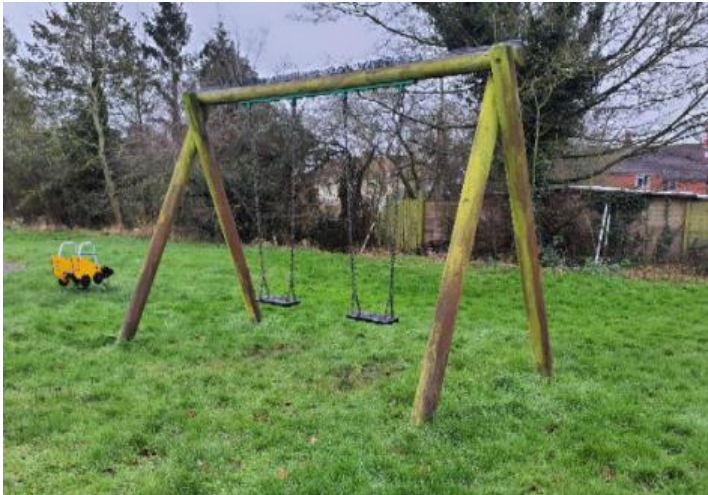
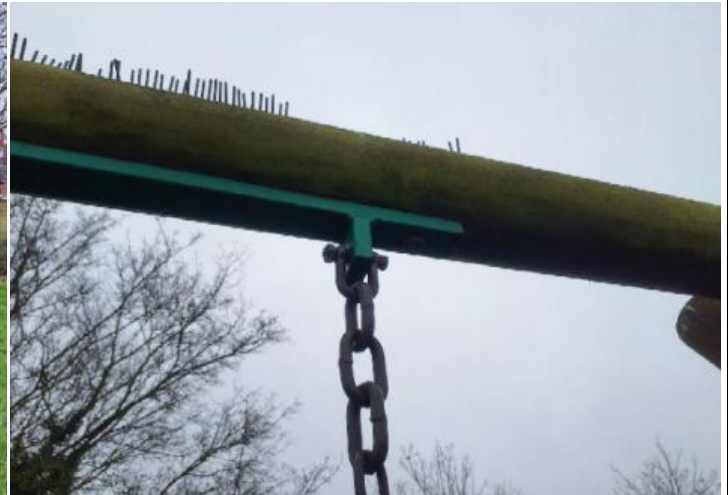
Item:	Swings - 1 Bay 2 Seat (Flat)	Risk Level:	L - Low Risk
Manufacturer:	A.E.Evans	Surface:	Grass Matrix Tiles

Finding:	There is some wear to the shackles	Action:	Monitor for any further deterioration and replace when 40% worn
-----------------	------------------------------------	----------------	---

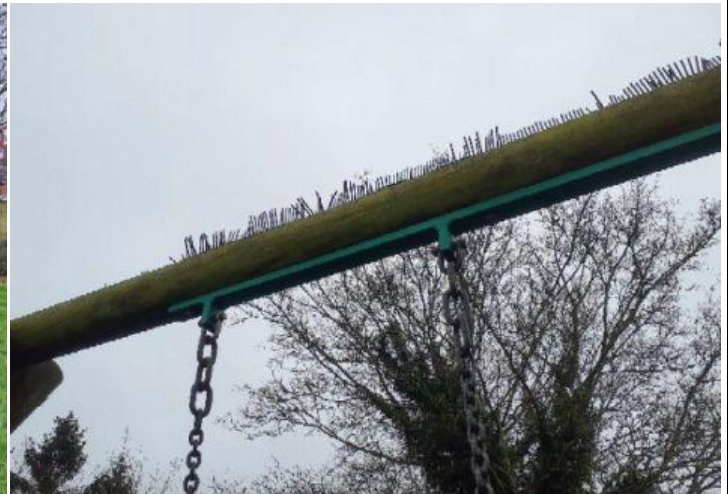
Item:	Swings - 1 Bay 2 Seat (Flat)	Risk Level:	V - Very Low Risk
Manufacturer:	A.E.Evans	Surface:	Grass Matrix Tiles

Finding:	The bushes are showing signs of wear	Action:	Monitor for any further deterioration and replace as required
-----------------	--------------------------------------	----------------	---

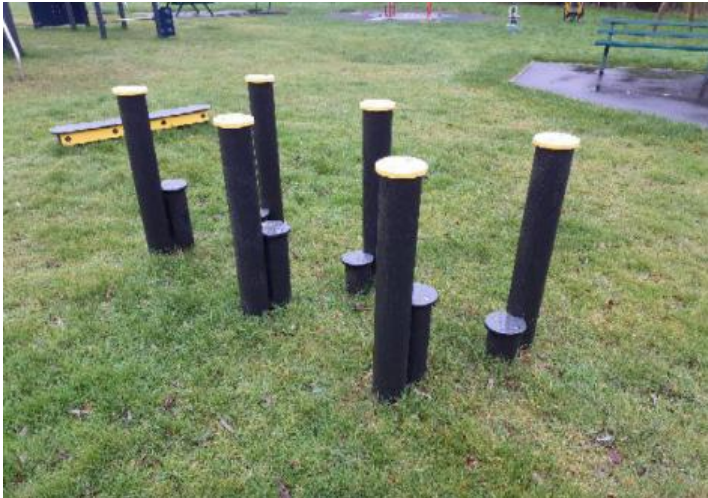
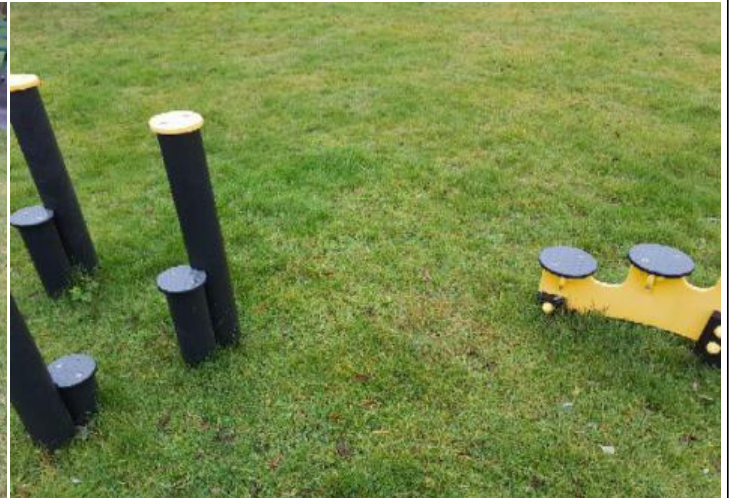
Item: Activity Equipment - Stilts
Manufacturer: Kompan Ltd

Finding: The step between the items is quite large and users may not be able to complete the step without touching ground, the items could therefore be considered to be within the falling space of each other, however the intention of the play activity continuity is easily apparent and foreseeable to the user

Action: Monitor - No remedial work recommended

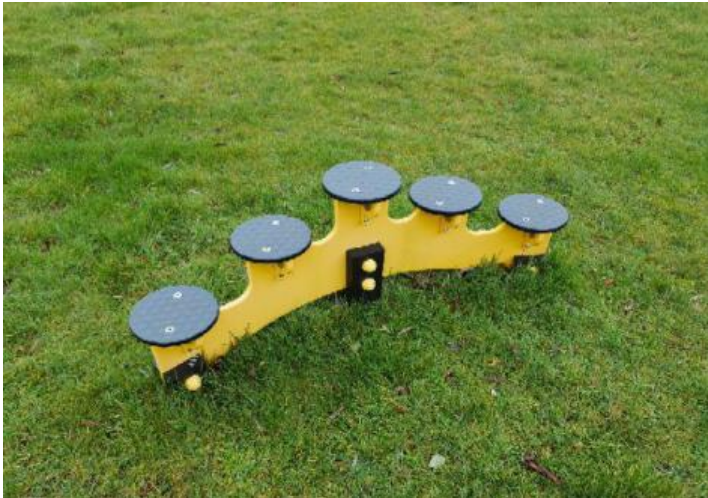
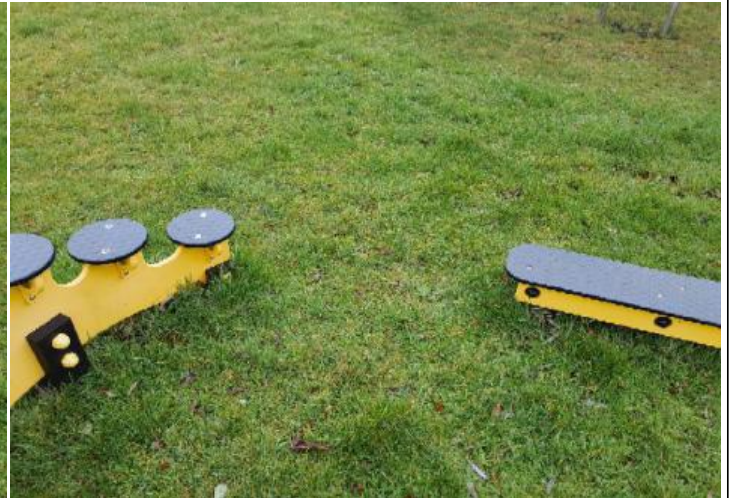
Item: Activity Equipment - Balance Beam
Manufacturer: Kompan Ltd

Finding: The step between the items is quite large and users may not be able to complete the step without touching ground, the items could therefore be considered to be within the falling space of each other, however the intention of the play activity continuity is easily apparent and foreseeable to the user

Action: Monitor - No remedial work recommended

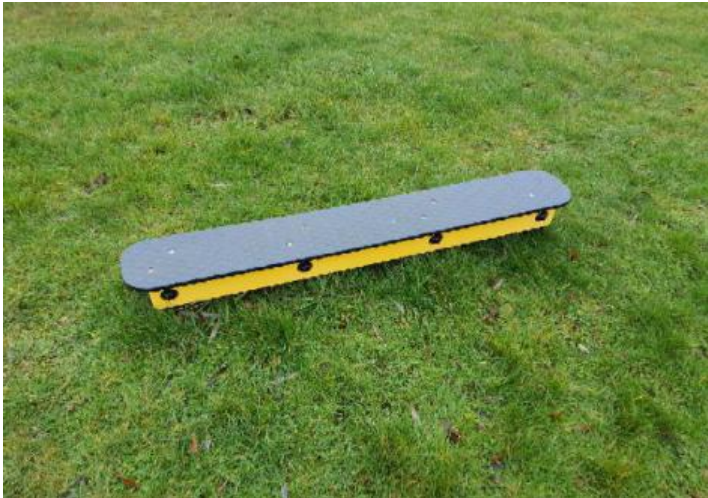
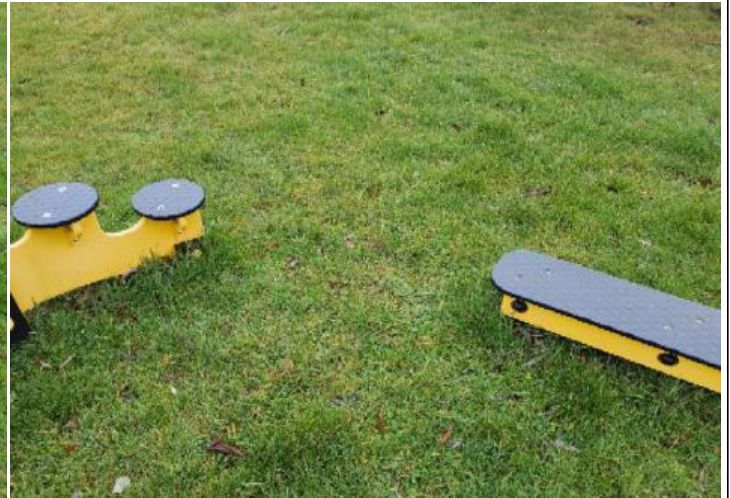
Item: Activity Equipment - Balance Beam
Manufacturer: Kompan Ltd

Finding: The step between the items is quite large and users may not be able to complete the step without touching ground, the items could therefore be considered to be within the falling space of each other, however the intention of the play activity continuity is easily apparent and foreseeable to the user

Action: Monitor - No remedial work recommended
