Annual Inspection

Mid Suffolk District Council

Buxhall

Off Mill Road, Suffolk, IP14 3DS

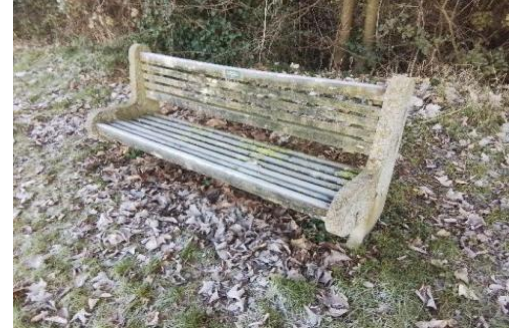
Item: Bench
Manufacturer: Not Identified
Surface Type: Grass
Item Quantity: 1
Equipment Compliance: N/A
Surface Area Compliance: N/A

There is some evidence of rot in the timber - Monitor for any further deterioration and replace as required

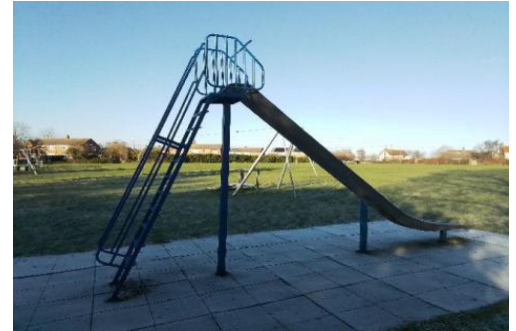
Item: Free Standing Slide
Manufacturer: Wicksteed Playgrounds
Surface Type: Rubber Tiles
Item Quantity: 1
Equipment Compliance: No
Surface Area Compliance: No

There are gaps opening in between the tiles - Monitor for any further deterioration and repair as required

The item fails to meet the requirements of BS EN 1176 Part 1 4.2.7.2 head and neck entrapment in the barriers and/or steps - Monitor - No remedial work recommended

The paintwork on this item has been damaged or worn exposing the metal underneath which is rusting - Treat any rusting components and repaint

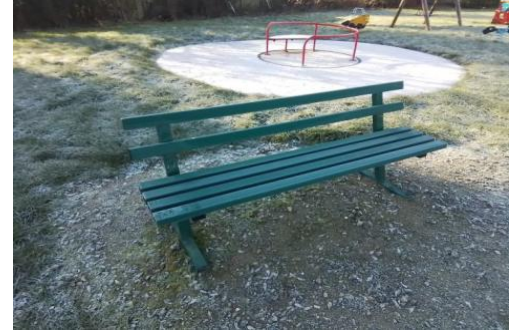
Item: Bench
Manufacturer: Not Identified
Surface Type: Grass
Item Quantity: 1
Equipment Compliance: N/A
Surface Area Compliance: N/A

There are post / end caps missing from the item - Replace missing post caps
