the **play inspection** company

Annual Inspection

Mid Suffolk District Council

Buxhall

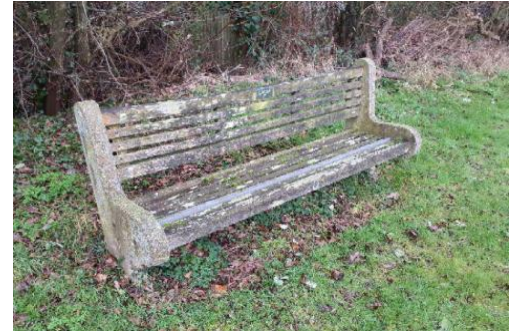
Item: Bench
Manufacturer: Not Identified
Surface Type: Grass
Item Quantity: 1
Equipment Compliance: N/A
Surface Area Compliance: N/A

There is some evidence of rot in the timber - Monitor for any further deterioration and replace as required

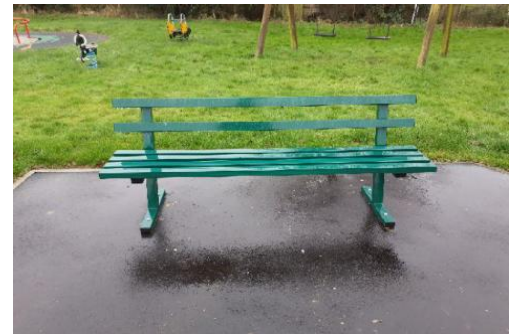
Item: Bench
Manufacturer: Not Identified
Surface Type: Tarmac
Item Quantity: 2
Equipment Compliance: N/A
Surface Area Compliance: N/A

There are post / end caps missing from the item - Replace missing post caps

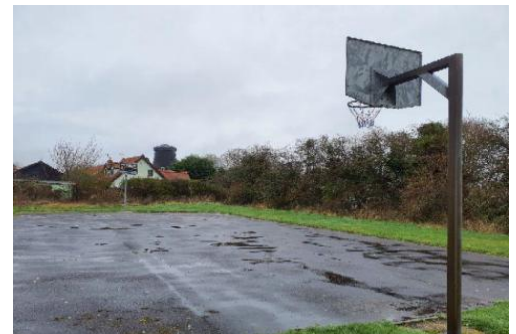
Item: Basketball Post
Manufacturer: Not Identified
Surface Type: Tarmac
Item Quantity: 2
Equipment Compliance: Yes
Surface Area Compliance: N/A

There is moderate damage to the surface - Repair the damaged areas of surfacing

There are trip hazards at the edges of the surface - Remove the trip points

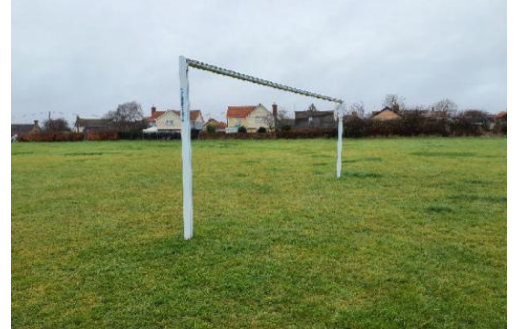
Item: Football Goal
Manufacturer: Not Identified
Surface Type: Grass
Item Quantity: 2
Equipment Compliance: N/A
Surface Area Compliance: N/A

NB: We have undertaken a maintenance inspection only of the football goal(s); full load testing falls outside the scope of our inspection. - Implement load testing as required

The item is slightly loose in its foundations - Monitor for any further deterioration and repair as required

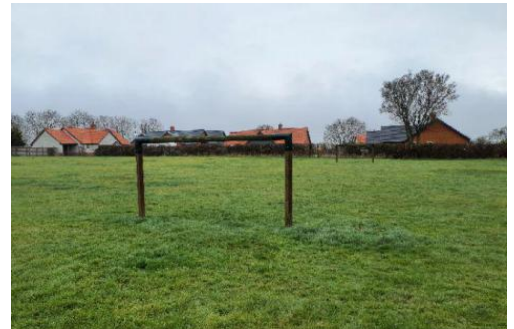
Item: Goal End
Manufacturer: Not Identified
Surface Type: Grass
Item Part Number:
Item Quantity: 2
Equipment Compliance: N/A
Surface Area Compliance: N/A

There is some strimmer / machinery damage apparent on the posts, this can penetrate the preservative applied to the timber and accelerate the rotting process - Monitor for any deterioration (rot) and replace as required

There is some evidence of rot in the timber - Monitor for any further deterioration and replace as required

The timber has a number of splits/shakes or air cracks and this may affect the stability or allow water ingress which will accelerate the rotting process - Monitor to ensure the splits do not cross through fixing points of the structure and/or cause any instability

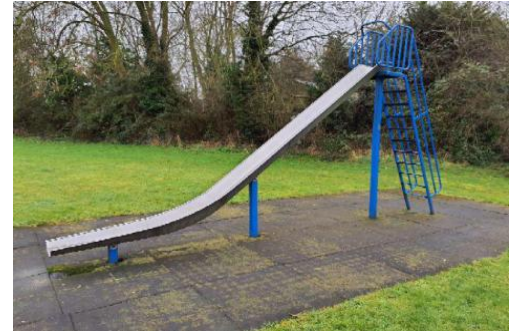
Item: Free Standing Slide
Manufacturer: Wicksteed Playgrounds
Surface Type: Rubber Tiles
Item Quantity: 1
Equipment Compliance: No
Surface Area Compliance: No

There is algae, silt or moss growth on the surface resulting in slippery conditions - Clean and treat appropriately

There are a number of dents in the slide surface - Monitor for any further deterioration and repair as required

The surfacing dimensions are short and do not meet with the requirements of the current applicable standard - Monitor - no remedial action recommended

There are gaps opening in between the tiles - Monitor for any further deterioration and repair as required

The item fails to meet the requirements of BS EN 1176 Part 1 4.2.7.2 head and neck entrapment in the barriers and/or steps - Monitor - No remedial work recommended

There are trip hazards at the edges of the surface - Reinstate surrounding surface levels to remove the trip points

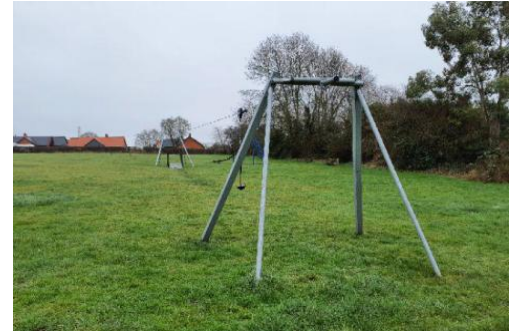
Item: Cable Runway
Manufacturer: Kompan Ltd
Surface Type: Grass Matrix Tiles
Item Quantity: 1
Equipment Compliance: Yes
Surface Area Compliance: Yes

We have completed a visual inspection of the suspension links, cable and fixing points from ground level, however it is not possible to fully inspect these areas without either hiring equipment to gain access or removing the cable and suspension and inspecting at ground level. We recommend that the main cable and fixing security is thoroughly inspected at least in accordance with the manufacturers recommendations to check for wear, damage, security or internal rusting; this will help to ensure the continued safe use of the equipment - Inspect in accordance with the manufacturers recommendations

The ropes/nets are worn/damaged in places - Monitor for any further deterioration and repair or replace as required

The seat connection cannot be inspected without dismantling the seat - Dismantle the seat to inspect the seat connection for wear

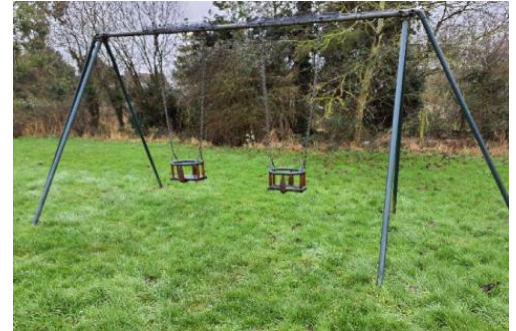
Item: 1 Bay 2 Seat (Cradle)
Manufacturer: Not Identified
Surface Type: Grass
Item Quantity: 1
Equipment Compliance: Yes
Surface Area Compliance: Yes

We do not recommend the installation of anti bird devices on equipment - Remove and replace with upturned cable ties

There is some notable evidence of chain wear - Monitor for any further deterioration and replace when 40% worn

There is some wear to the shackles - Monitor for any further deterioration and replace when 40% worn

The bushes are showing signs of wear - Monitor for any further deterioration and replace as required

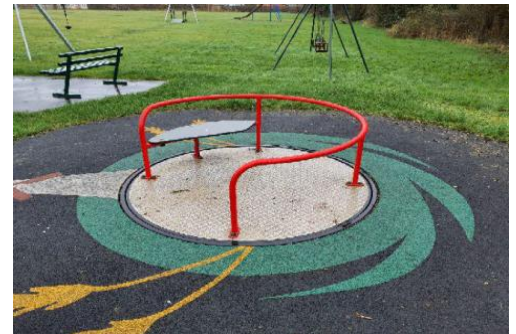
Item: Inclusive Roundabout
Manufacturer: Kompan Ltd
Surface Type: Wet Pour
Item Quantity: 1
Equipment Compliance: Yes
Surface Area Compliance: Yes

There are gaps opening between the surfacing and the edging surround or between the joints in the surfacing - Monitor for any further deterioration and repair as required

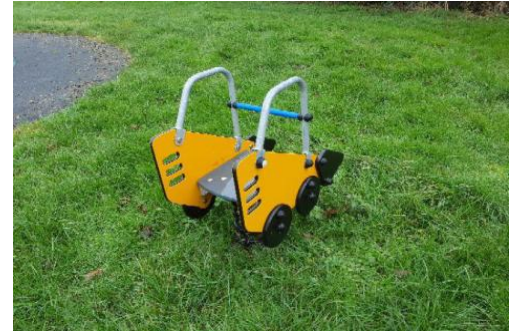
Item: Spring Tractor
Manufacturer: Kompan Ltd
Surface Type: Grass Matrix Tiles
Item Quantity: 1
Equipment Compliance: Yes
Surface Area Compliance: Yes

A number of fixing(s) have worked loose - Secure all loose fixings

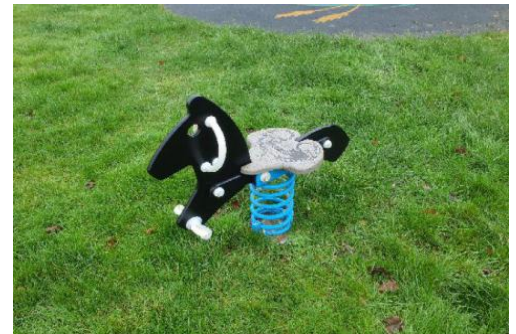
Item: Spring Horse
Manufacturer: Kompan Ltd
Surface Type: Grass Matrix Tiles
Item Quantity: 1
Equipment Compliance: Yes
Surface Area Compliance: Yes

There is some damage to the item - Monitor for any further deterioration and repair as required

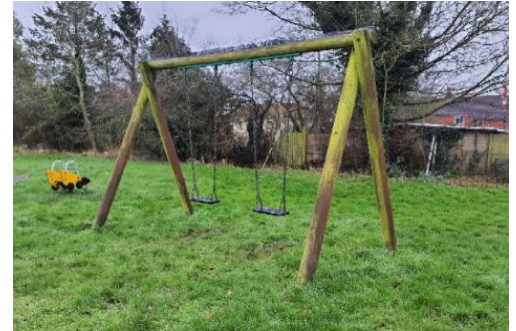
Item: 1 Bay 2 Seat (Flat)
Manufacturer: A.E.Evans
Surface Type: Grass Matrix Tiles
Item Quantity: 1
Equipment Compliance: No
Surface Area Compliance: Yes

We do not recommend the installation of anti bird devices on equipment - Remove and replace with upturned cable ties

There is some strimmer / machinery damage apparent on the posts, this can penetrate the preservative applied to the timber and accelerate the rotting process - Monitor for any deterioration (rot) and replace as required

There is some evidence of rot in the timber - Monitor for any further deterioration and replace as required

The chain openings are in excess of 8.6mm and do not meet the recommendations of BS EN 1176 Part 1 - Monitor - No remedial work recommended

There is some notable evidence of chain wear - Monitor for any further deterioration and replace when 40% worn

There is some wear to the shackles - Monitor for any further deterioration and replace when 40% worn

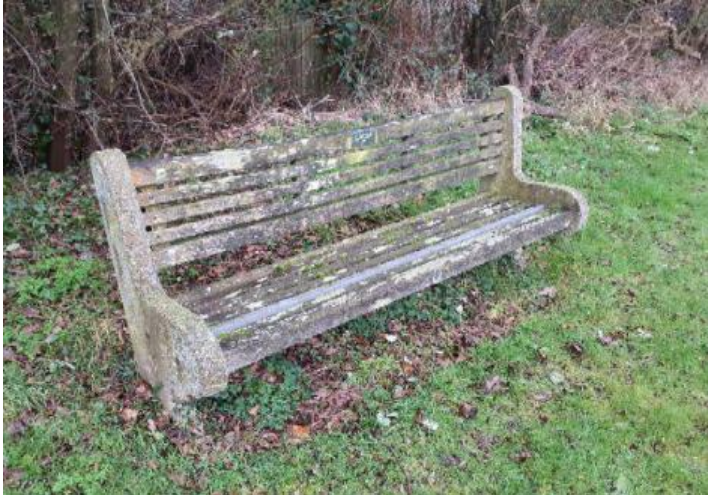
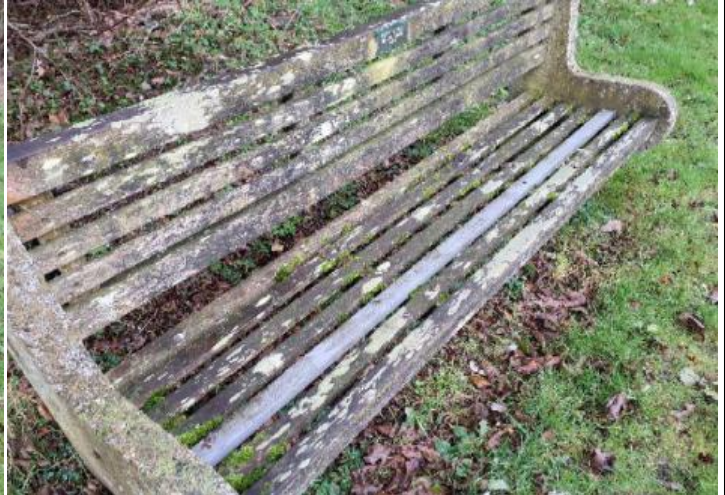
Item: Ancillary Items - Bench
Manufacturer: Not Identified

Finding: There is algae or moss on the surface of the equipment

Finding: There is some evidence of rot in the timber

Action: Clean and treat appropriately

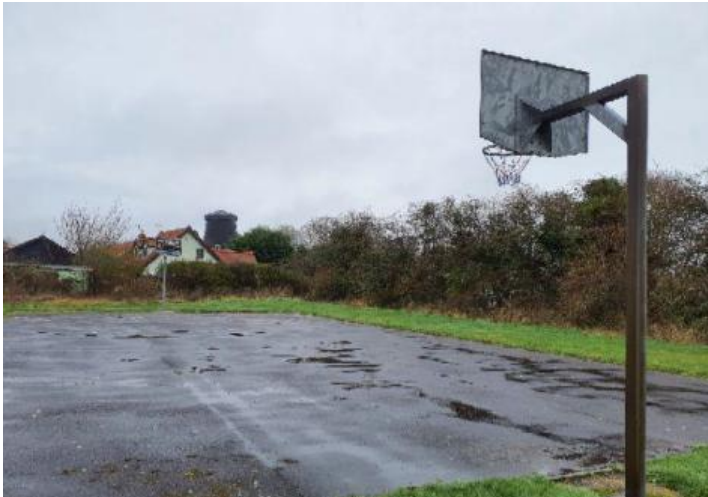
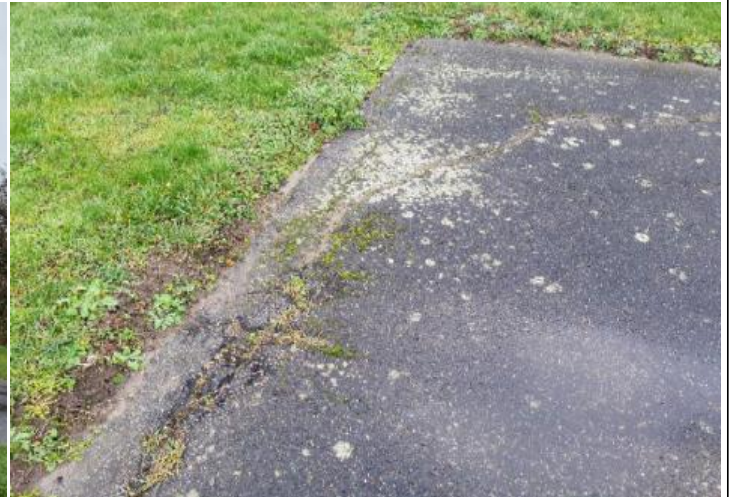
Item: Multi Use Games Area - Basketball Post
Manufacturer: Not Identified

Finding: There is weed / vegetation growth on, between, or around the edges of the surfacing **Action:** Remove weed / vegetation growth

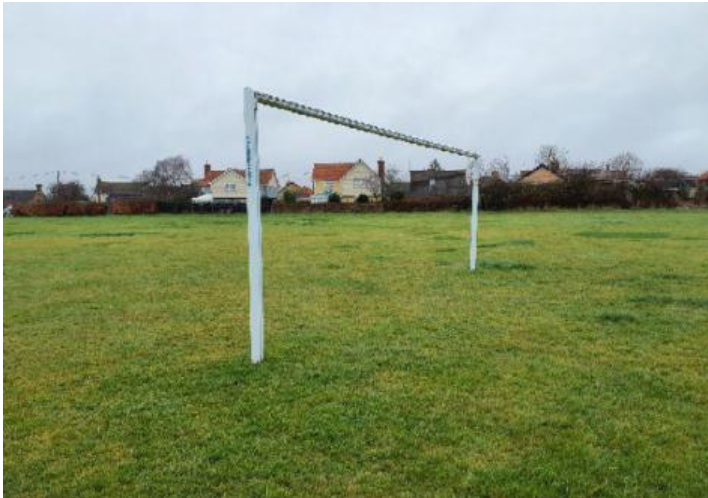
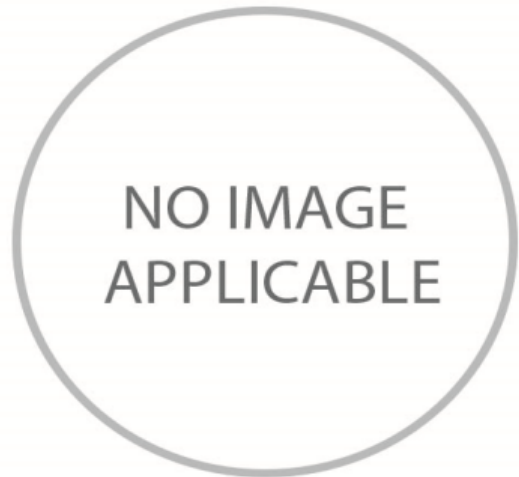
Item: Multi Use Games Area - Football Goal
Manufacturer: Not Identified

Finding: NB: We have undertaken a maintenance inspection only of the football goal(s); full load testing falls outside the scope of our inspection.

Action: Implement load testing as required

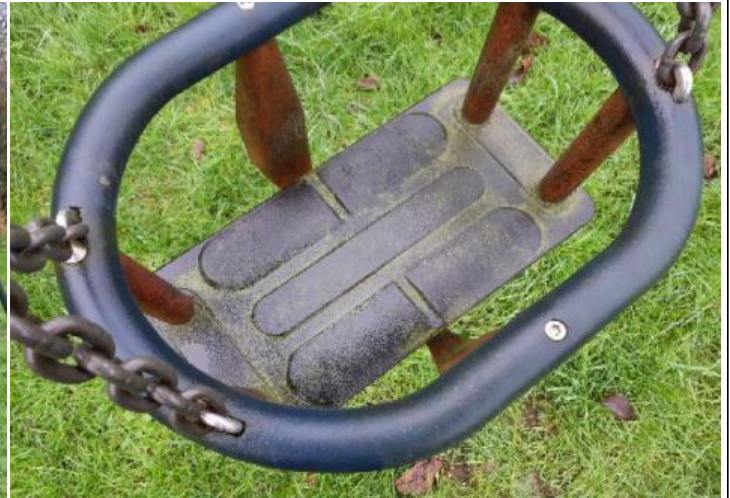
Item: Swings - 1 Bay 2 Seat (Cradle)
Manufacturer: Not Identified

Finding: There is algae or moss on the surface of the equipment

Action: Clean and treat appropriately

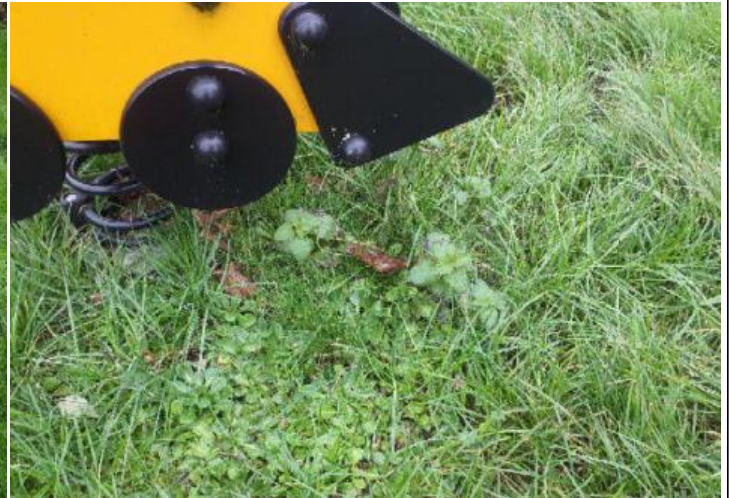
Item: Rocking Equipment - Spring Tractor
Manufacturer: Kompan Ltd

Finding: There is nettle growth by the equipment

Action: Remove and maintain

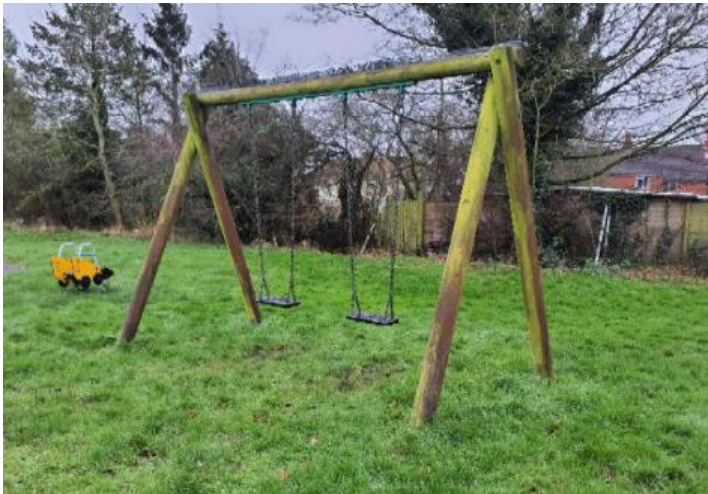
Item:	Swings - 1 Bay 2 Seat (Flat)	Risk Level:	V - Very Low Risk
Manufacturer:	A.E.Evans	Surface:	Grass Matrix Tiles

Finding:	The bushes are showing signs of wear	Action:	Monitor for any further deterioration and replace as required
-----------------	--------------------------------------	----------------	---
